## TRIM IN LIMIT PIN

### For Bravo One, Two, and Three

#### NOTICE to INSTALLER

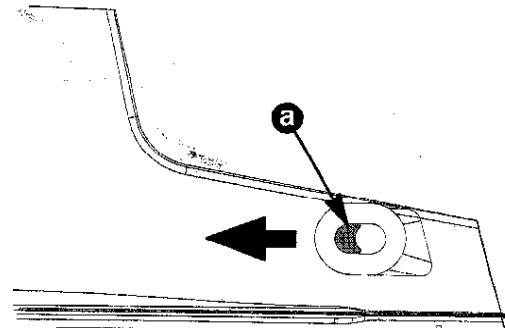
75157

Bravo One and Two (Positioned Forward)

a - Trim-In Limit Pin

1. Ensure that the Trim-In -Limit Pin is positioned as shown for the appropriate Bravo model.

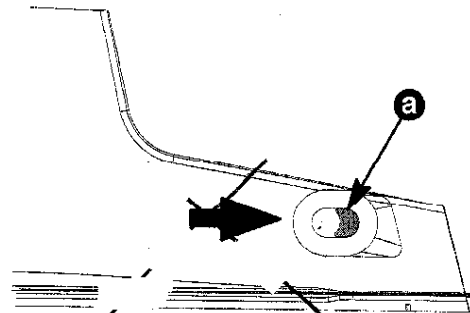
75158

Bravo Three (Positioned Aft)

**IMPORTANT:** The position of the Trim-In Limit Pin on the Bravo Three stern drive unit should only be changed after the boat has been properly tested.
