Figure 1 Weil McLain Boiler Plate. Installed in 1994 by Augustitus Plumbing, Little Falls, NJ

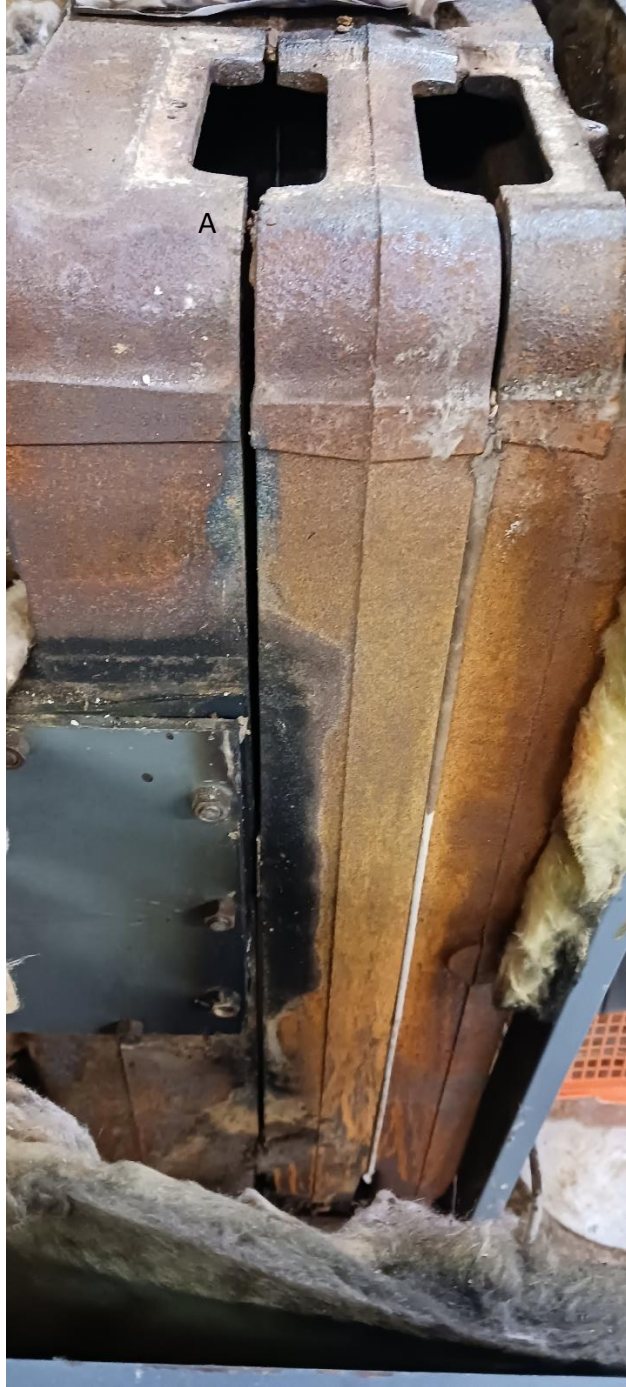
Figure 2 Fireside joint failure. Long region of inter-section sealant allowed combustion smoke to escape the combustion/flue passage and into the room. Smoke residue is apparent on middle boiler section and adjacent Cover Plate for Heater Opening (Rectangular.) Middle boiler section (A) is misaligned with the front and back sections. Bead of sealant between front and middle section remains mostly intact. This condition started very early in the life of the boiler but was only noticed on a poor ignition instance. There was only ever a puff of smoke that escaped at ignition and a nearby smoke detector about the boiler never detected smoke.

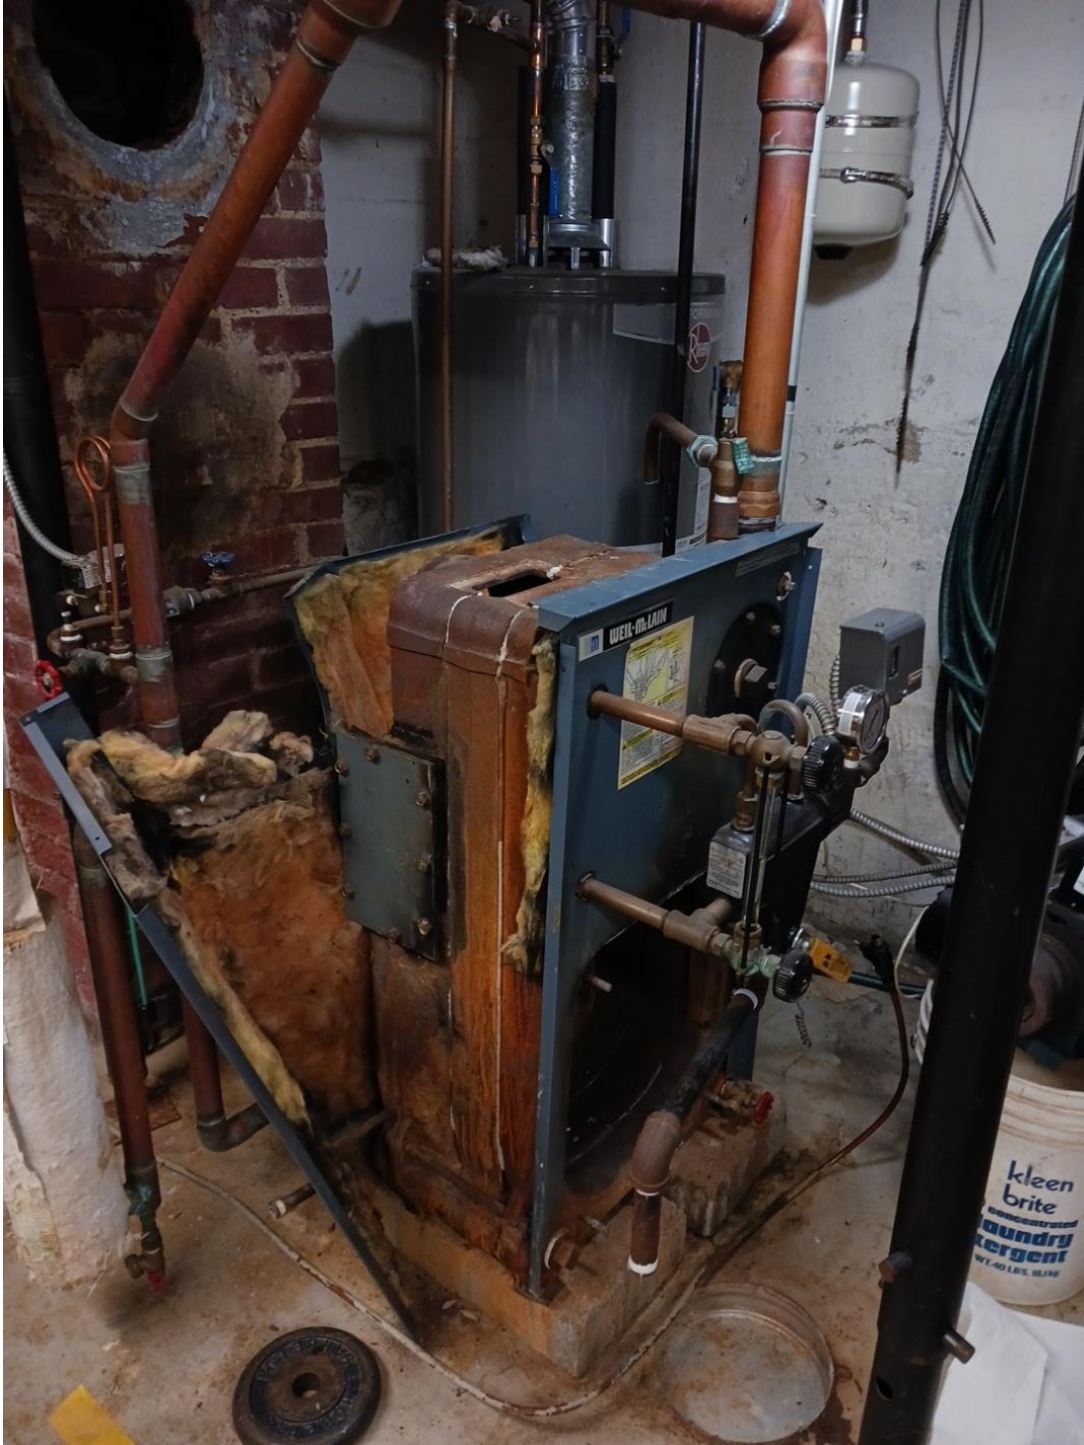
Figure 3 Disassembly of sheet metal shroud. Removal of a few sheet metal screws and alteration of one back section enabled the shroud to be easily removed. Removal of the burner and controls was necessary to remove the front panel, though it was learned that was not necessary for this repair.

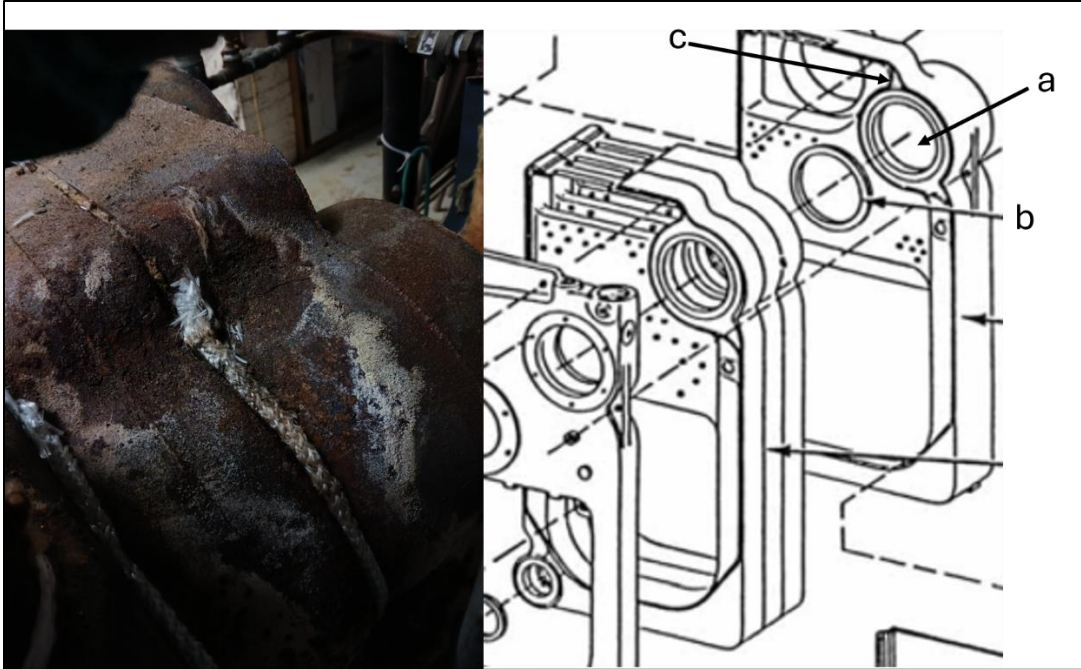
Figure 4 Early evidence of leakage. Ceramic rope was mistakenly packed into the region between the sections around the water heater chamber (a), thinking that smoke was escaping from the joint. The staining was in fact tracks of steam leaking past the 6" internal elastomer seals (b). It was later learned that the internal flue seal turned to the inside of the section that isolates the heater chamber (c). The placement of the rope seal in the region shown was a mistake.

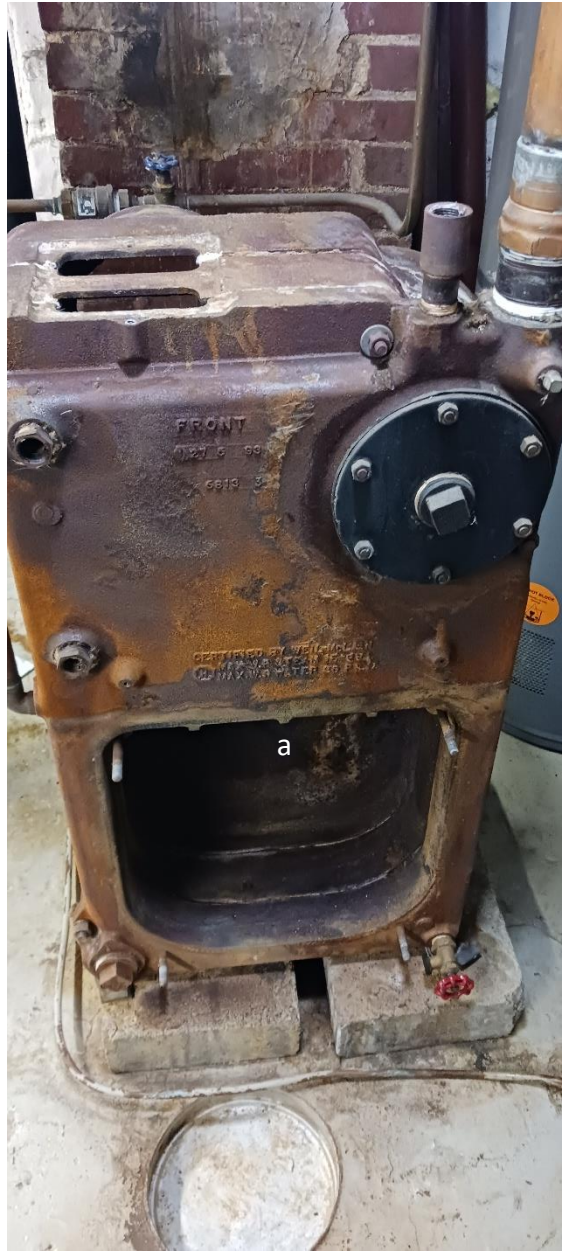
Figure 5 Boiler Front. The fire box was significantly deteriorated (not shown). Evidence of steam or condensate infiltration (a.) The boiler was deemed no longer usable and was taken out of service.

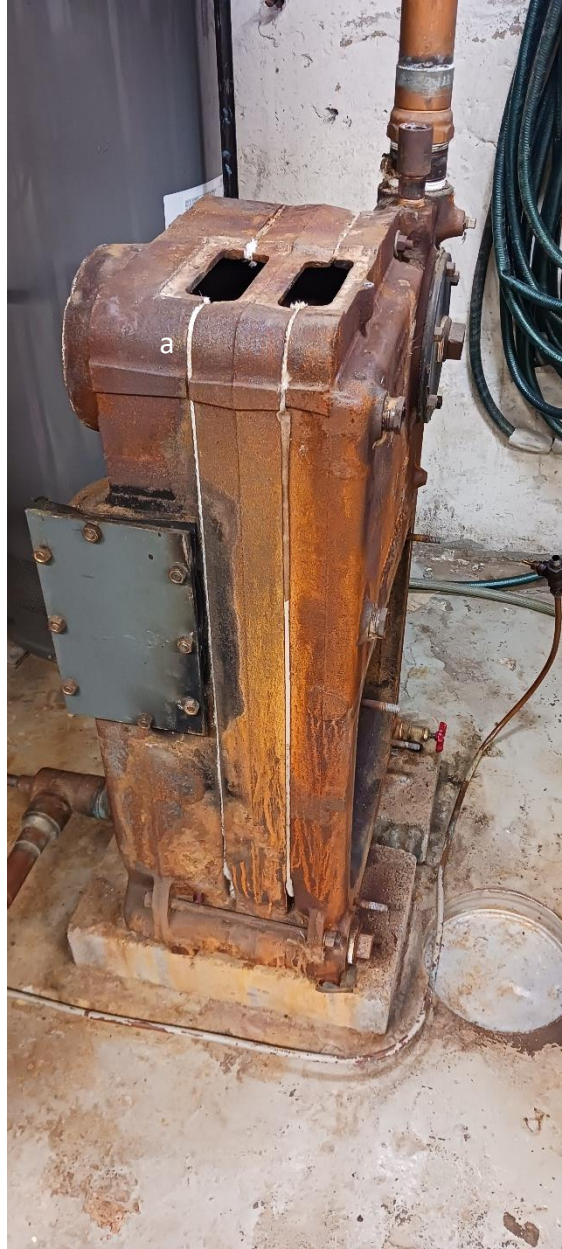
Figure 6 Boiler side view. $\frac{1}{4}$ " ceramic rope (measured closer to $\frac{3}{8}$ ") was packed into gap (a) between the rear and middle sections. By stretching the rope and forcing it with a putty knife, the rope was neatly emplaced to seal off combustion gases. This step was taken to seal off escaping flue gases before the steam leak on the opposite side was discovered.

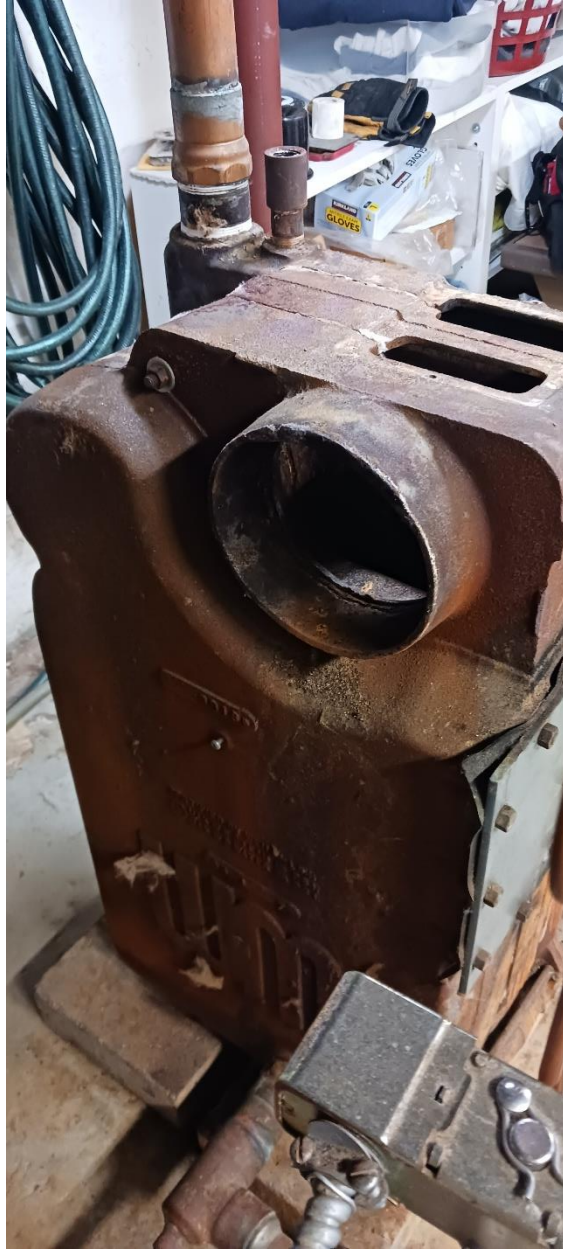
Figure 7 Boiler rear section. The rear section was isolated from the existing piping by cutting a 1-1/4" copper condensate return pipe leading to the 2" main boiler port. This rear section was too big and heavy to remove from its location on the pillow block. The best that could be done to facilitate movement of the section was a come-a-long secured to the ceiling joists above the boiler. At times, the section was tilted backward to rest on the bottom blow-down valve. Solenoid for automatic water fill valve is shown (lower right.)

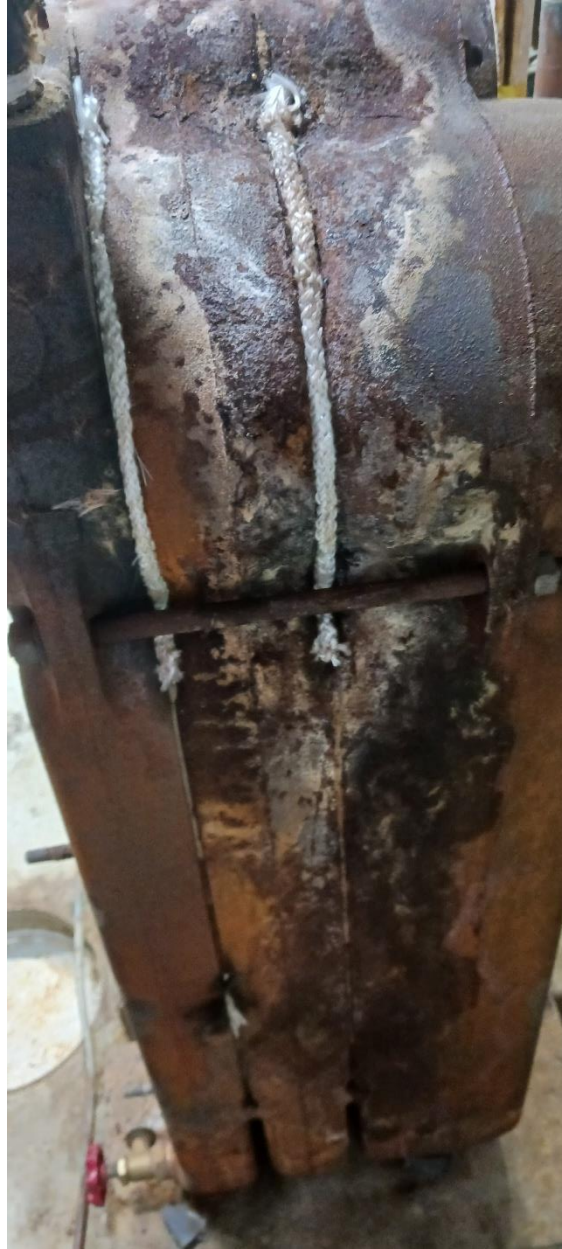
Figure 8 Evidence of steam leak. Ceramic rope mistakenly packed into gaps between sections. $\frac{1}{2}$ " tie rod shown near the top. There is a $\frac{3}{8}$ " tie rod on the opposite side of the heat exchanger cavity.

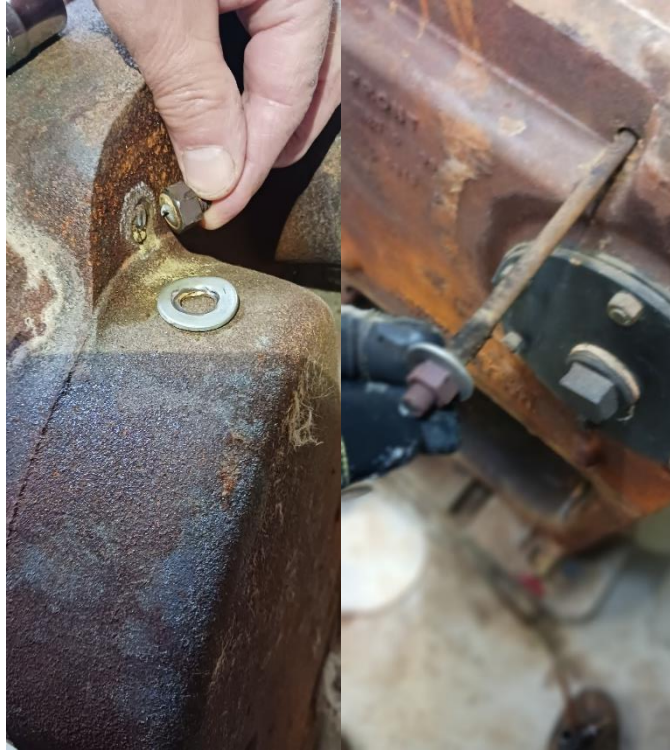
Figure 9 *5/16" tie rod. This rod would have been exposed to steam causing the nut to seize onto the threads. Not much torque occurred before the rod sheared at the nut. There was no split-lock washer on the tie rod.*

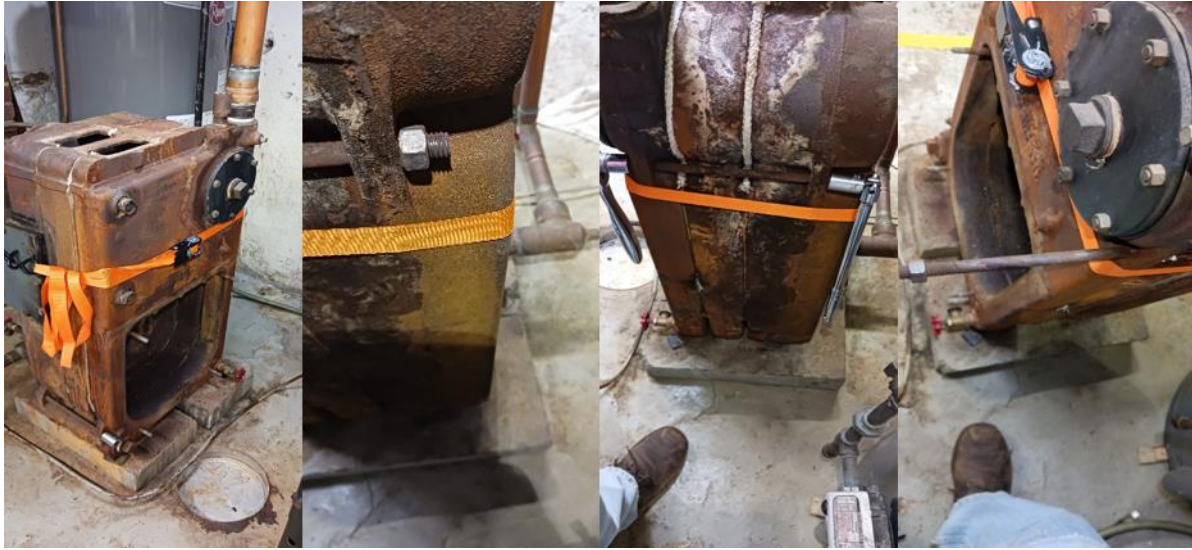
Figure 10 Tie Rod Removal Preparation Ratchet tie down was used to ensure the sections would stay together as the tie rods were removed. A $\frac{3}{4}$ " socket on a $\frac{1}{2}$ " breaker bar was used to loosen the nut on one end of the rod. The rod was in good condition so it was ultimately reused.

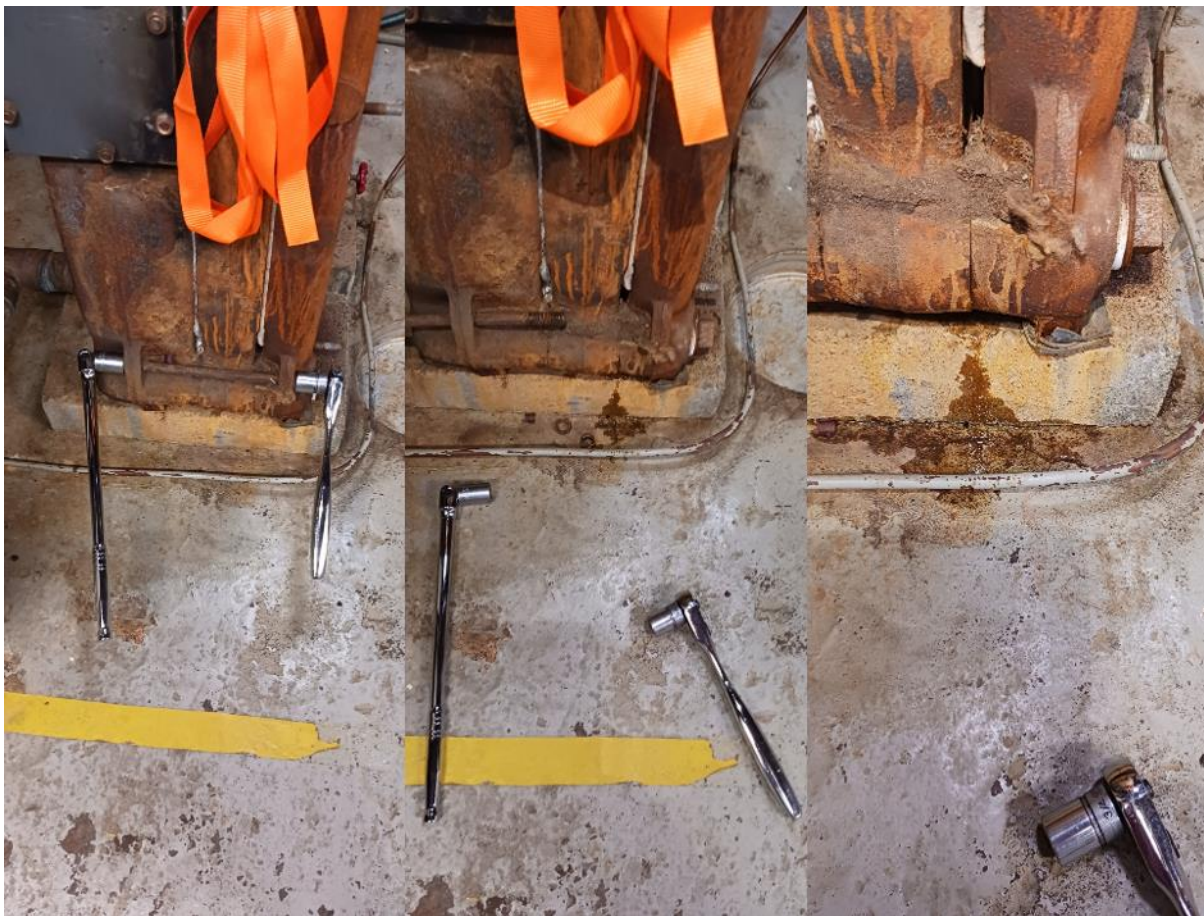
Figure 11 Lower waterside tie rod. Water immediately leaked out of the joint when the rod was loosened. Once the ratchet tie strap was loosened, the boiler sections separated without much more than by one hand.

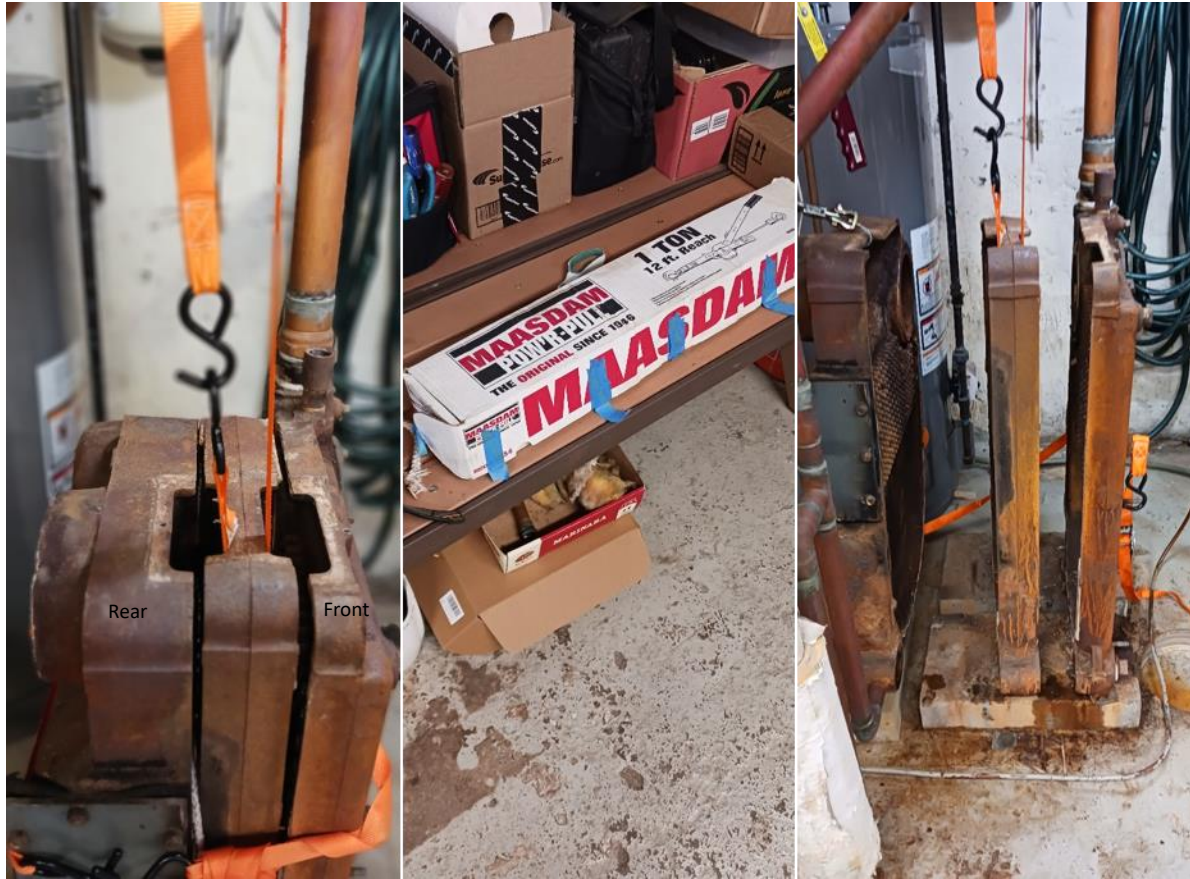
Figure 12 Rigging the middle section. Using a Maasdam come-along, the middle section was easily lifted out of place. It was heavy but could be lifted on to a nearby work bench by hand. Most of the rehabilitation and preparation was done on the middle section. With some care, the section was moved in and out of the assembly without using a come-along. The front section was still piped to the main header and remained in position throughout the rest of the rebuild.

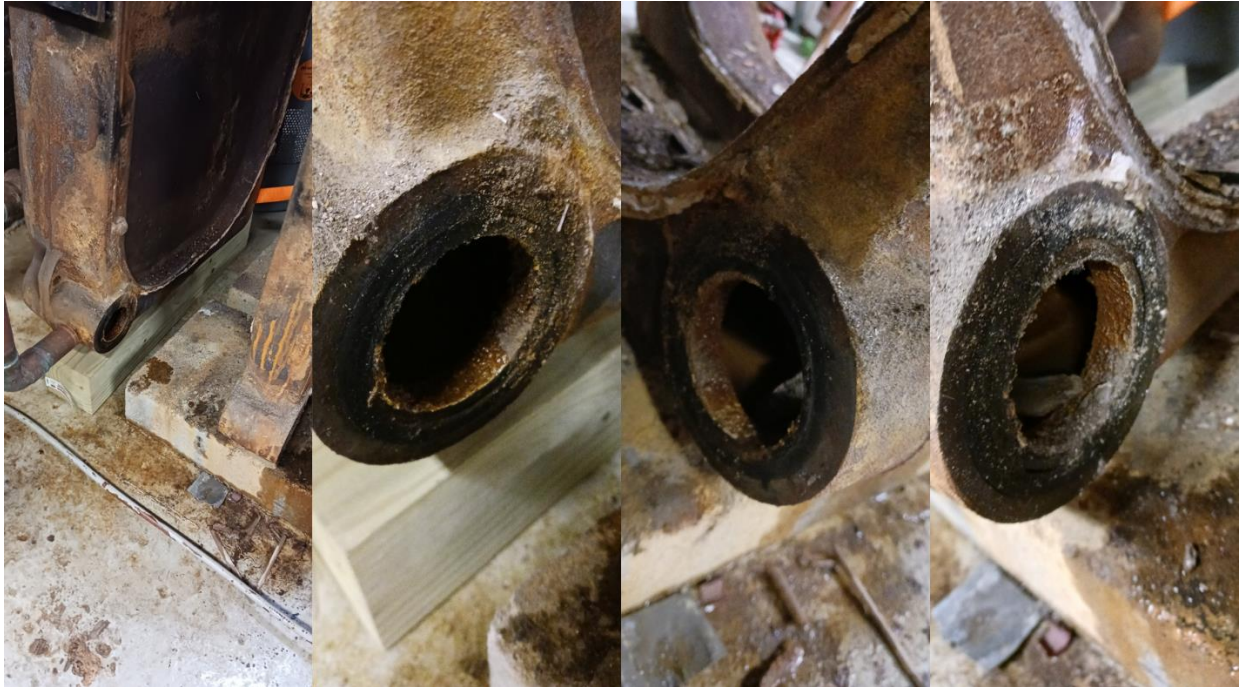
Figure 13 Waterside joints. The seal glands and opposing faces of the water section joints were found to be in very good condition. Though they look rough in these photographs, they cleaned up easily to almost new condition. The 3" elastomer are still emplaced in their glands.

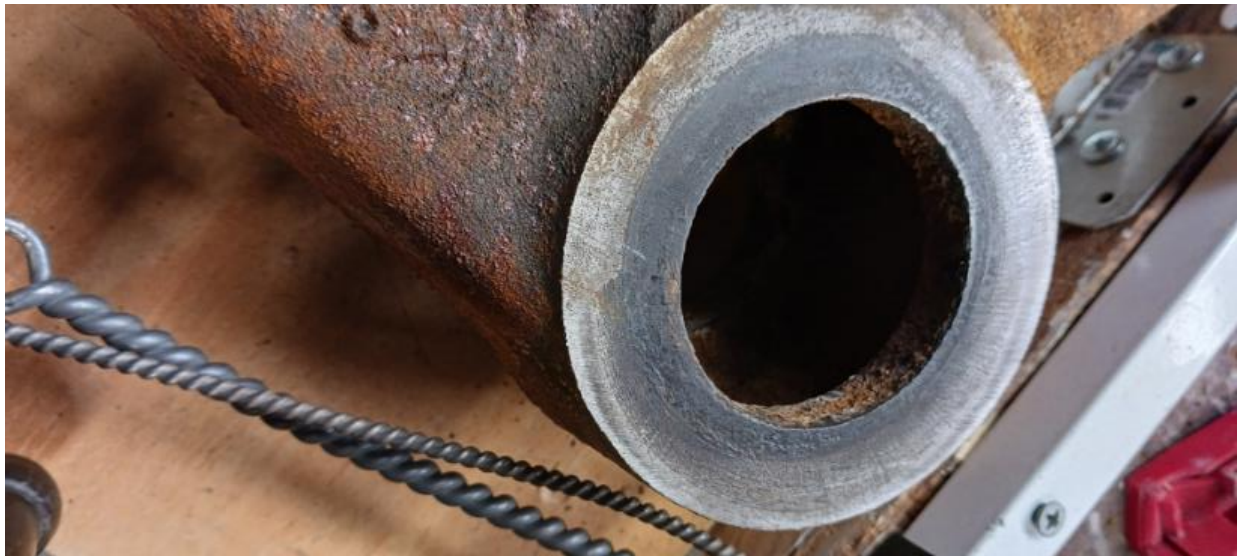
Figure 14 Restored waterside-joint face. The faces of the section joint were all very near perfect. A file and emery cloth were used to remove and deposits and clean the surfaces. A minor amount of corrosion was located to the inside diameter of the elastomer seal, otherwise, the surface was intact.

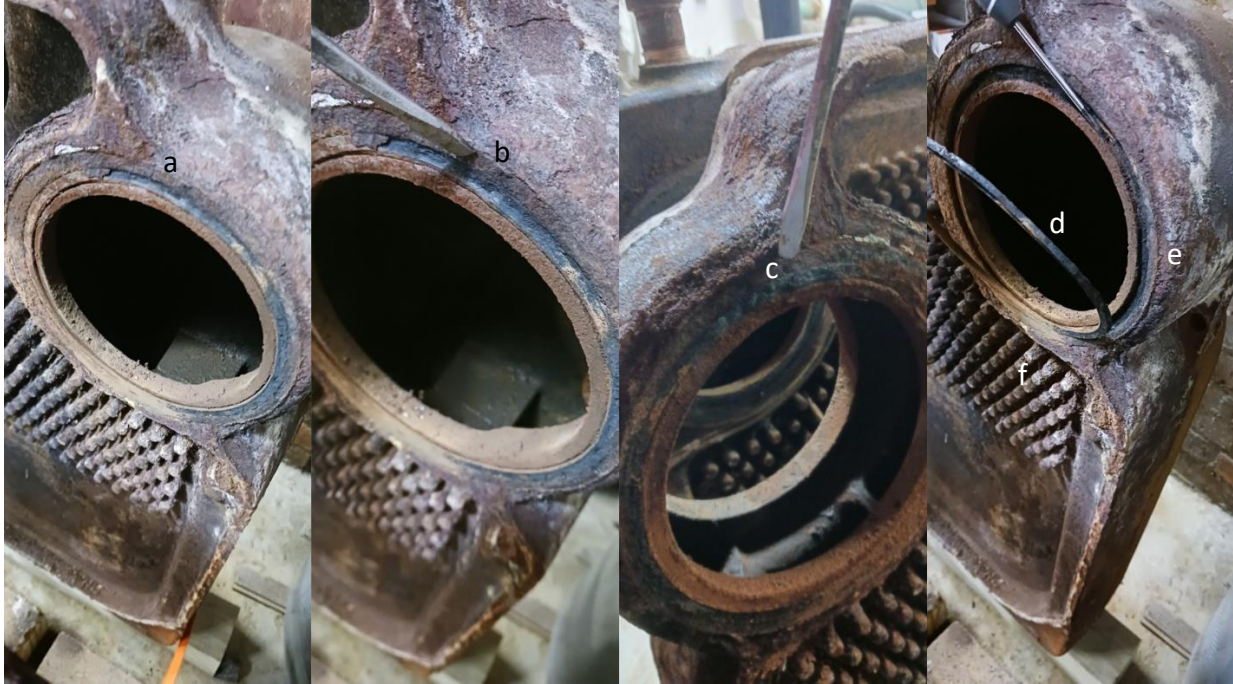
Figure 15 Steam side joints. The steam side joints were moderately compromised (a.) Both 6" elastomer seals had varying degrees of deterioration and lamination (b), causing corrosion of the glands but not on the opposing faces. A layer of the seal shown in (b) transferred to the opposing face (c). This evidence leads to the cause of failure where steam corroded the interface of the seal and gland and eventually eroded a path of escape. Corrosion of the glands was in a 20° arc and less than 0.020" deep at any point. The elastomer seals (d) were easily removed. They were still supple though not usable. It was a short path for steam to escape to the outside of the boiler (e) or to the inside (fireside) (f). The flue seal, part cement and rope were completely missing around the heater cavity. A fair amount of work was done to restore the groove that would seat the ¼" ceramic rope.

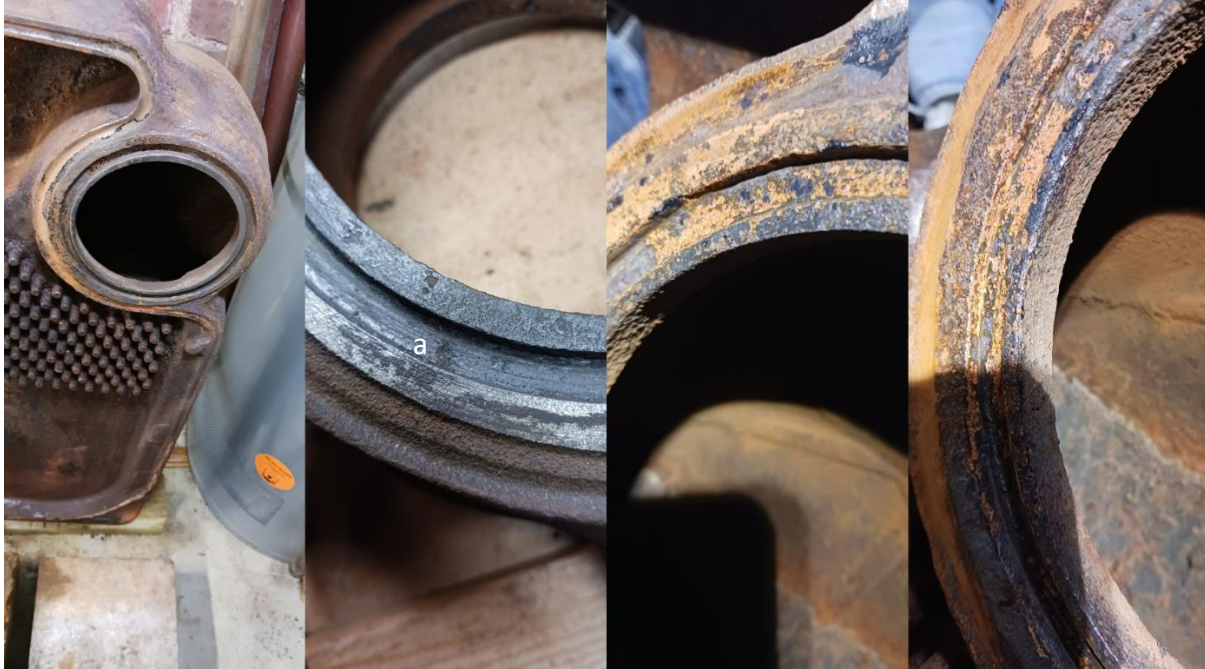
Figure 16 Restored section glands. The glands and faces were restored mostly with hand tools. The most effective tool for removing rust, scale, cement and cording was a ¼" wood chisel. It fit nicely into the gland and easily cut through any buildup. Pitting in the bottom of the gland was limited to a 20° arc and filled with JB Weld Steel epoxy. The restoration was better than represented in these photos. A very small void (a) was subsequently filled with another application of JB Weld. A steel file was used to dress across the surfaces. Most of the gland surfaces were very slightly damaged with only surface corrosion as seen in images 3 and 4. The planned sealing procedure was to use Permatex Red high temperature gasket material to seal all surfaces and create an adjunct gasket for the elastomer seals. The Permatex was painted on all mating surfaces with a thin layer using a small artist brush (stole from wife's art kit). The Permatex also provided a good slip layer during assembly to allow easy section alignment.

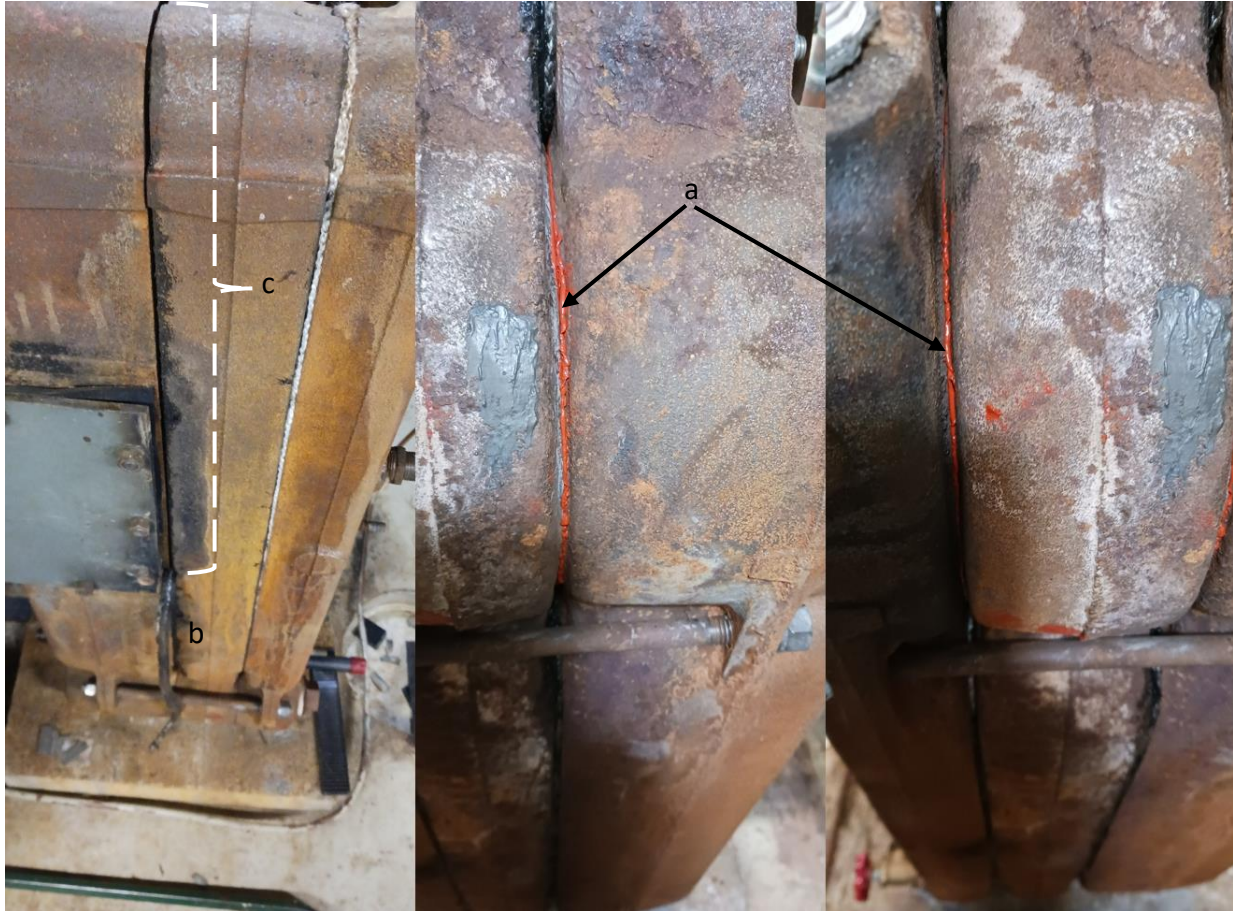
Figure 17 Reassembled boiler sections. A small amount of Permatex gasket material squeezed out of the 6" upper joints(a). Tie rods were torqued to 50 ft-lb for the 1/2" rod (as per Weil-McLain technical support) and 25 ft-lb for the 3/8" rod (as per calculated yield for carbon steel.) Sections were allowed to rest for 24 hours then re-torqued with some tightening. After another 24-hour relaxation, no further tightening occurred at torque values. After three practice dry assemblies, it was learned that the ceramic rope was impeding the 6" rear/middle sections from mating. A length of rope (b) was eliminated from the assembly to allow the sections to mate. The gap (c) was later filled Rutland 2000°F furnace cement. Both joints were then covered with cement (not shown.) Boiler was hydrostatically tested to 4 psi for 24 hours with no leaks. Boiler was tested to 2 psi steam pressure with no leaks (water or smoke). Boiler cycled several times and has been at rest for 5 days without leaks.
