**Applicability:** DBX Venue Pro 360s

**Conditions:** The 2 pin power connector can cause muted outputs due to dropping voltage across the connector.

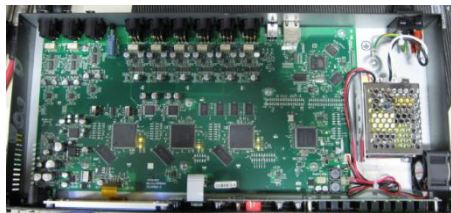
1. Remove the center T15 Torx screw and 4 Phillips screws 2 on each side, remove cover.
