## Problems with a 2019 NuCamp 400 Bondock Lite – 06/12/2019.

### Problems found upon delivery.

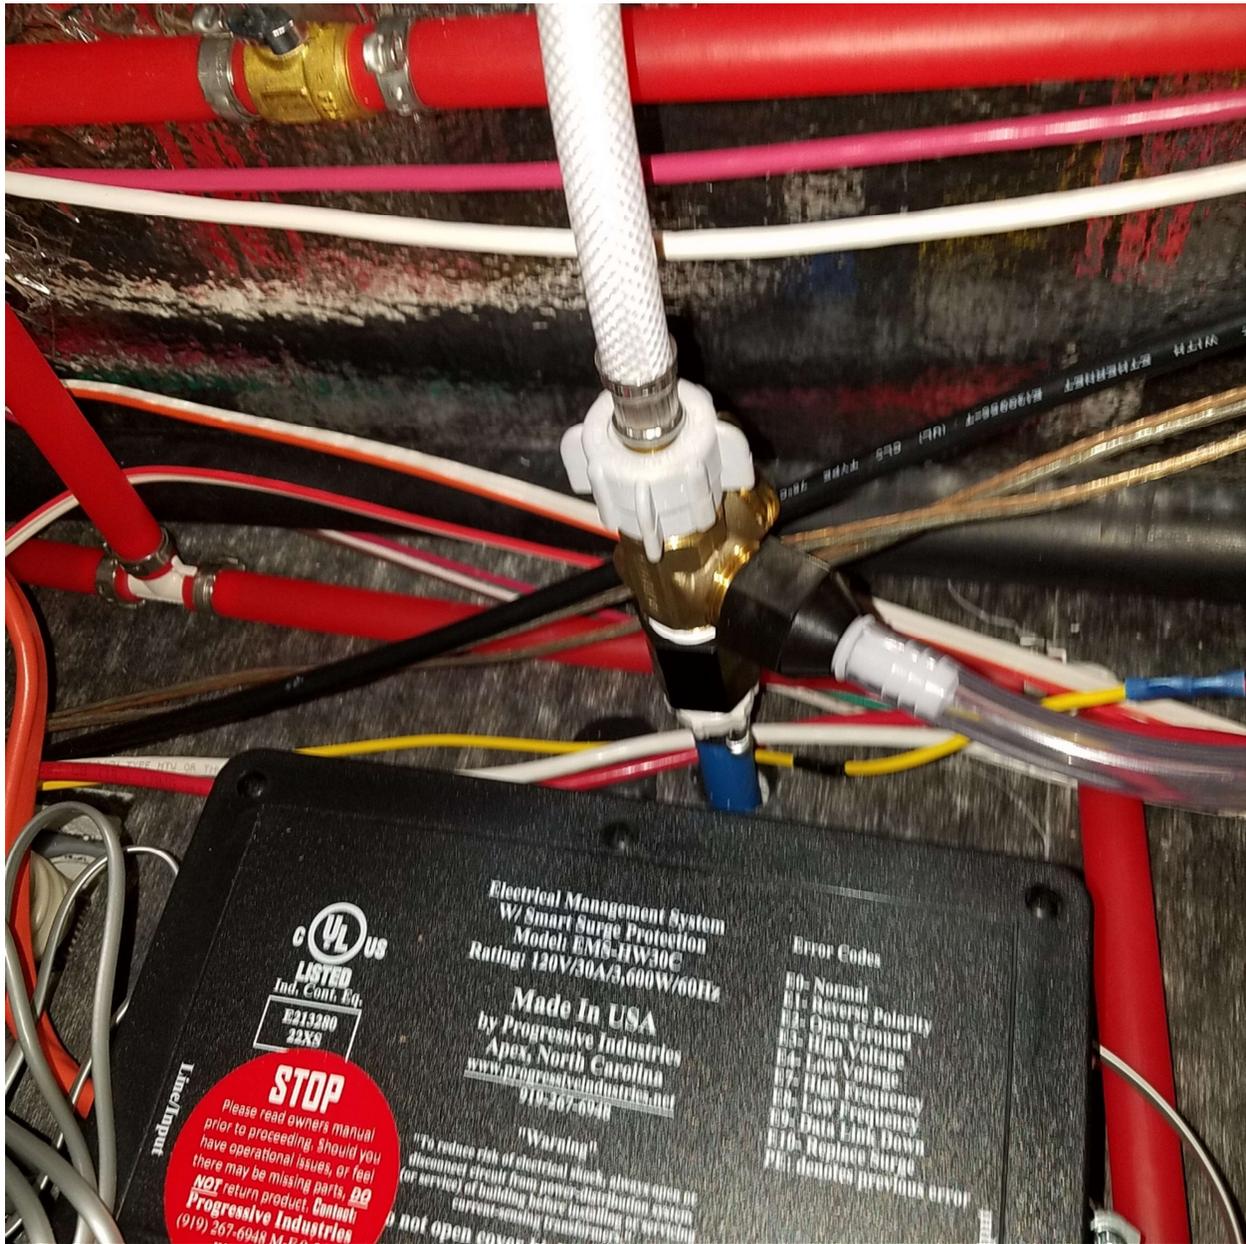
The winterizing valve added by Miller Trailer Sales, great idea!

Secondly, the pump line to the cold water tank has a 't' valve fitted, so that to winterize, you just put the clear pipe in the antifreeze, switch the valve position and use the trailer water pump to pump the antifreeze through. Great idea!

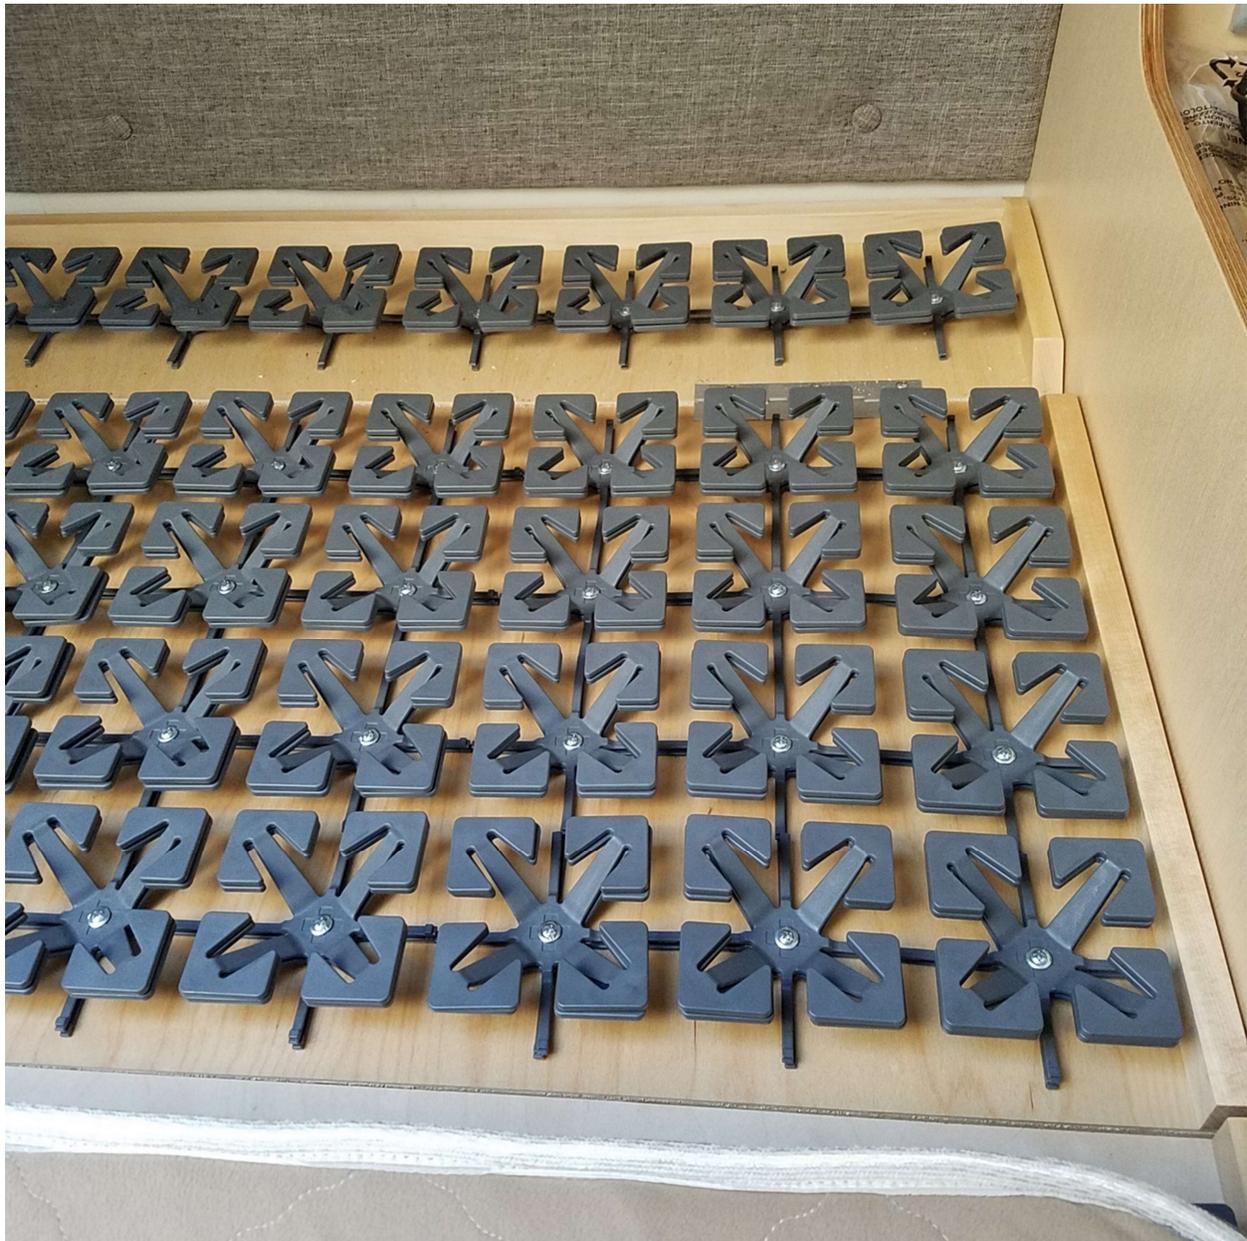
I prefer a hard bed to lie on. The Froli sleep system advertised to be used (Travel system?) can be adjusted to hard by application of additional rings attached to each spring. I had already purchased the rings. When I went to fit them, they were not correct. Fortunately, Froli customer service came up with a solution for the different type of Froli spring system which is now fitted to all Tab 400's. Extra blocks of springs can be purchased and sat inside the installed ones after removing the location screws. This worked great.

With double springs: note each section should be secured with 4 screws minimum not two as before. I elected to screw every hole. The original screws must be replaced as they are too short.

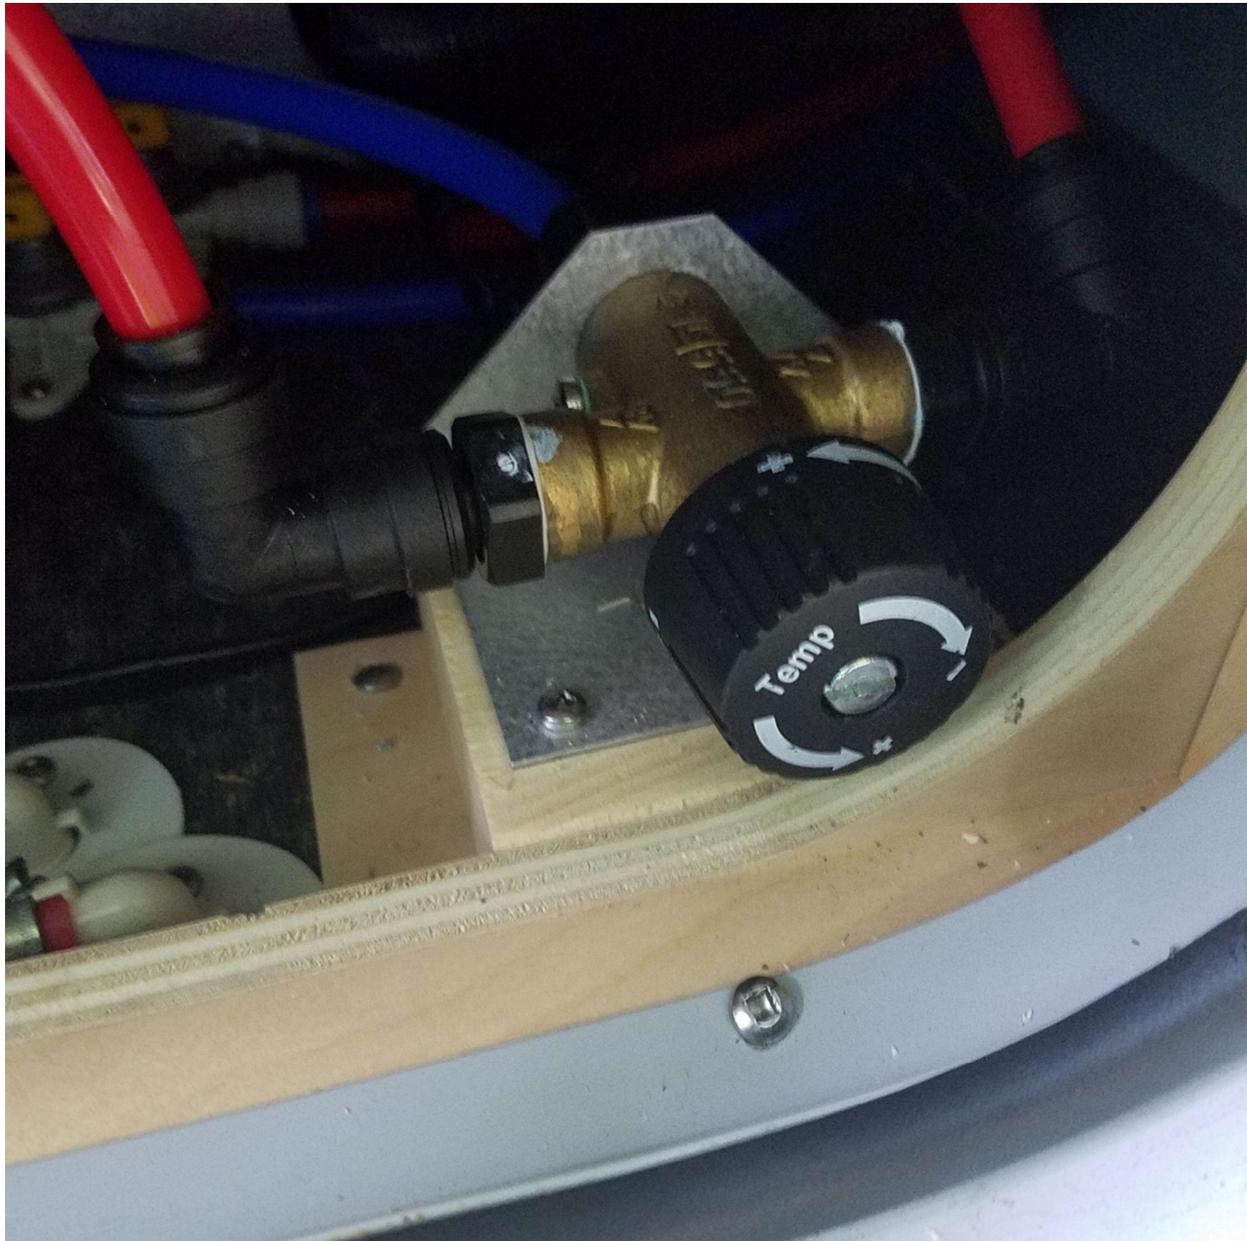
After de-winterizing and flushing out the antifreeze, the hot water system was run. The water would be hot for a second then lukewarm. After contacting Aldi, the engineer diagnosed that the temperature mixer valve needed calibrating. It was already turned to full hot. So the engineer advised me to remove the dial (one screw) and rotate the temperature control further  $\frac{1}{4}$  turn at a time until the water was a little more than hot. Then refit the dial and turn back until the temperature was as I wanted. This procedure is also in the Aldi manual.

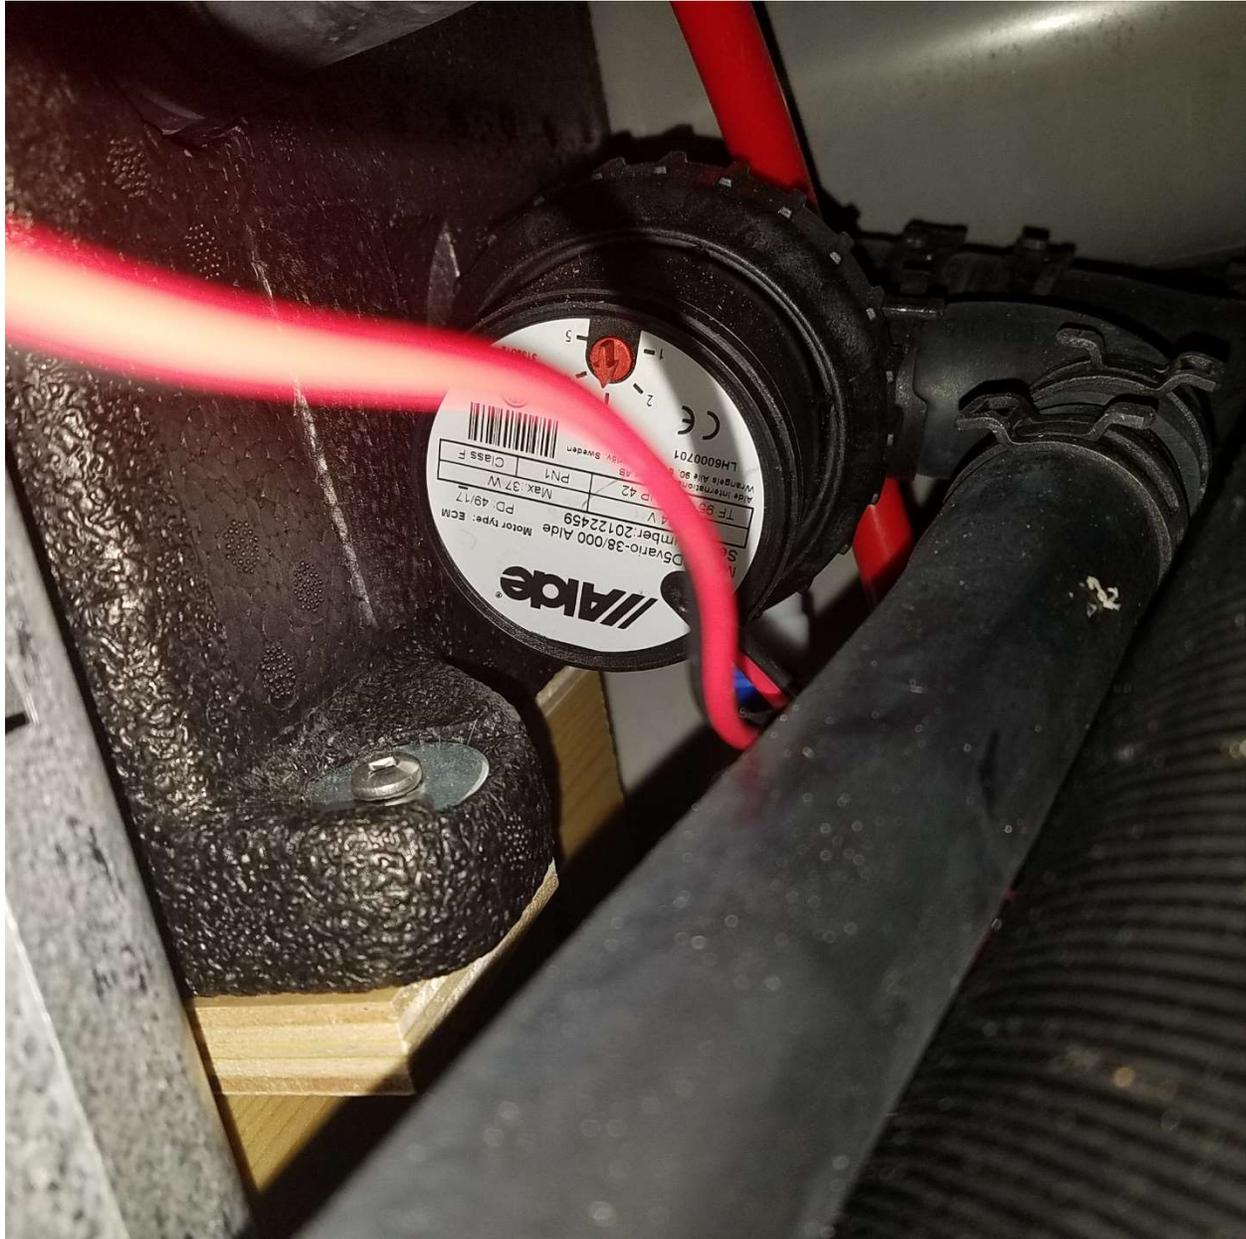
This noise, which seemed to come from the red tank was so loud as to wake me from sleep. I had to turn off the heating system at night to sleep. The same Aldi engineer had me do some system checks and found that the pump speed control on the tank had been left at 5, this should never be greater than 2 ½ to 3 except for a short burst to clear trapped air. Set back to 3 and all was quiet.

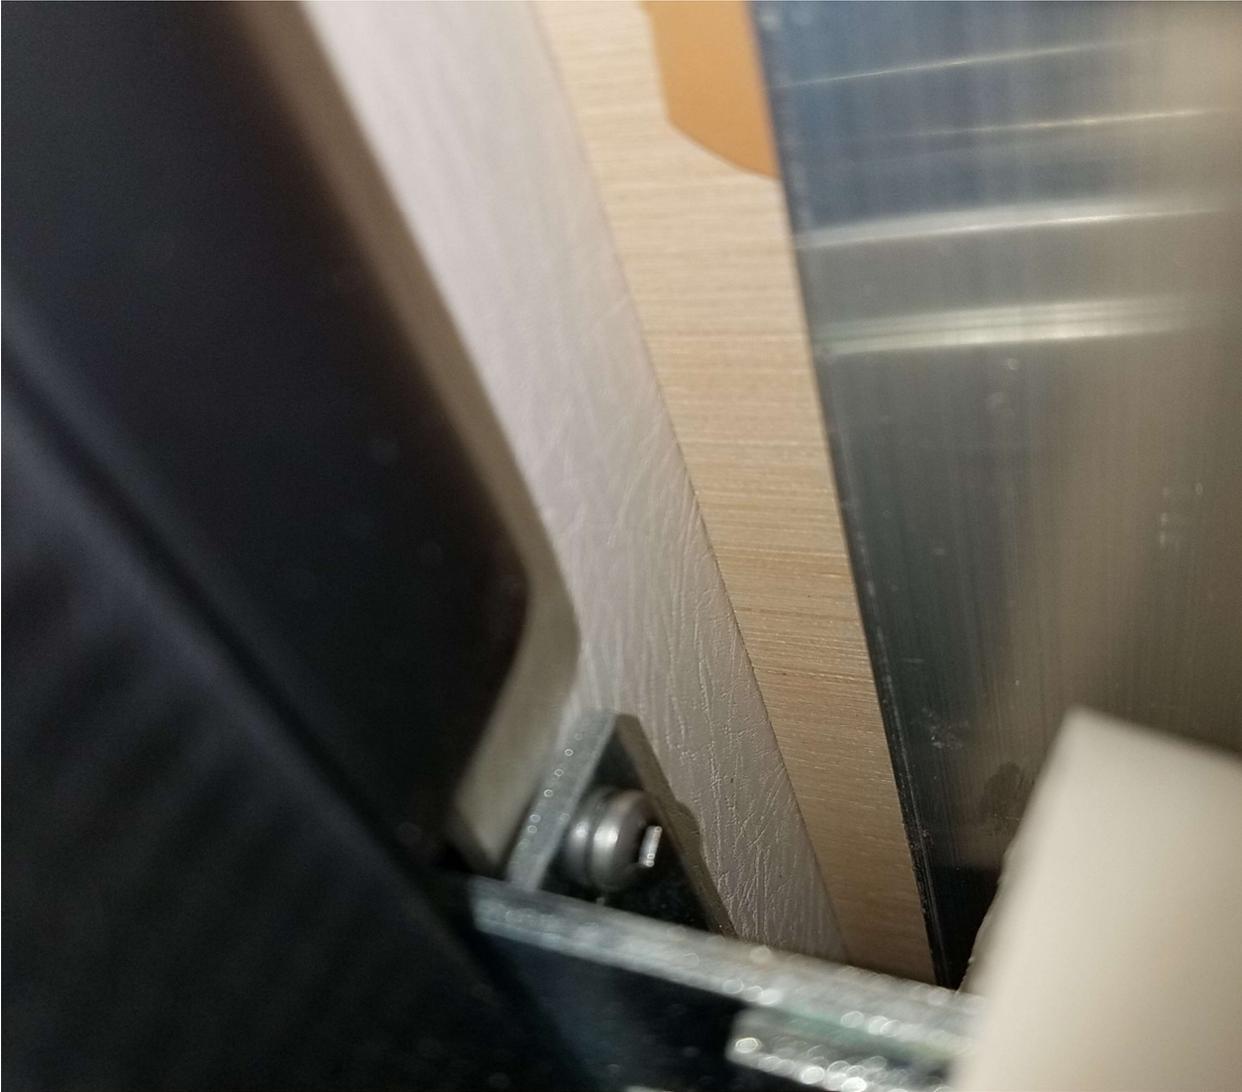
From when I got the trailer home, I always had to slam the door to get it to lock. Sometimes taking a few tries. After my last trip it would not lock at all. I found the lock plate on the door frame very loose. The bolts securing it to the trailer wall looked loose. The only way to get to this is to remove the inner door frame – 6 square drive screws.

Loose screws securing lock plate to door

With this removed, the screws can be accessed. I bought larger self - tapping screws as the originals were stripped out. Even after fitting these, and the lock plate feeling more solid, it was still possible to rock the lock plate from side to side.

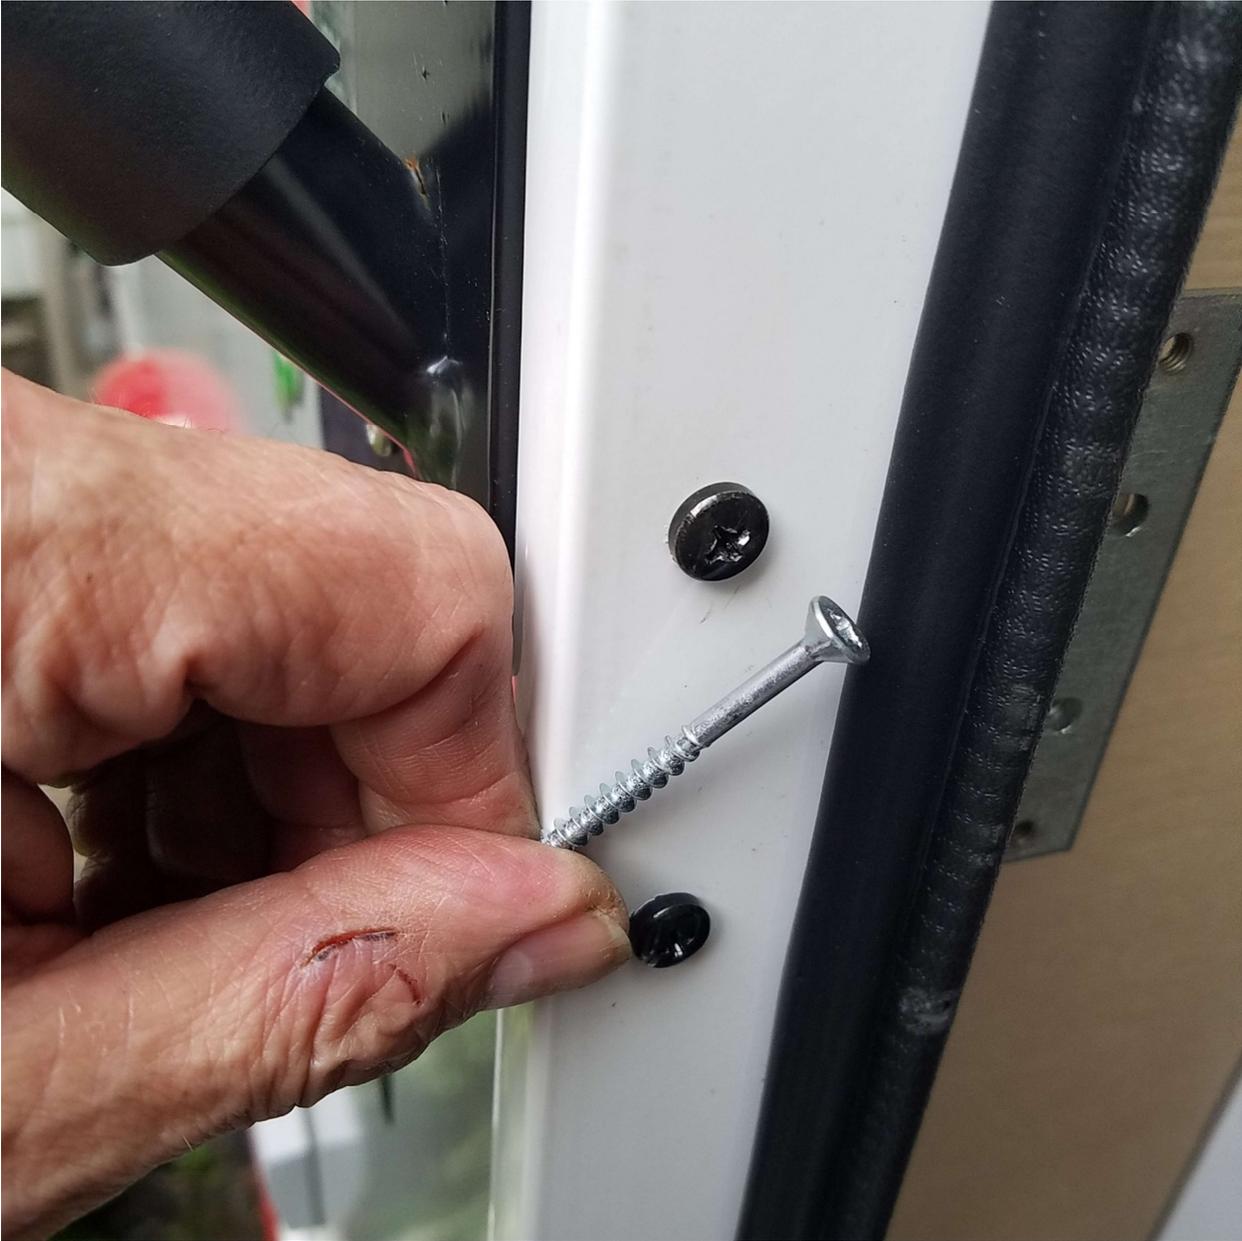
Screws in the side of the frame: new M6 pan heads and a comparison of the useless screw they replaced.

I found that there were two screws on the side of the frame, countersunk which did nothing, passing straight through the lock plate into wood somewhere. After removing these screws, I could see that the lock plate had two threaded holes (M6x1.0 thread). So I replaced the original screws with pan head machine screws, which then secured the lock plate in two directions and was now totally solid. I also noticed that the door seal was damaged from the original installation, with the internal spring showing.

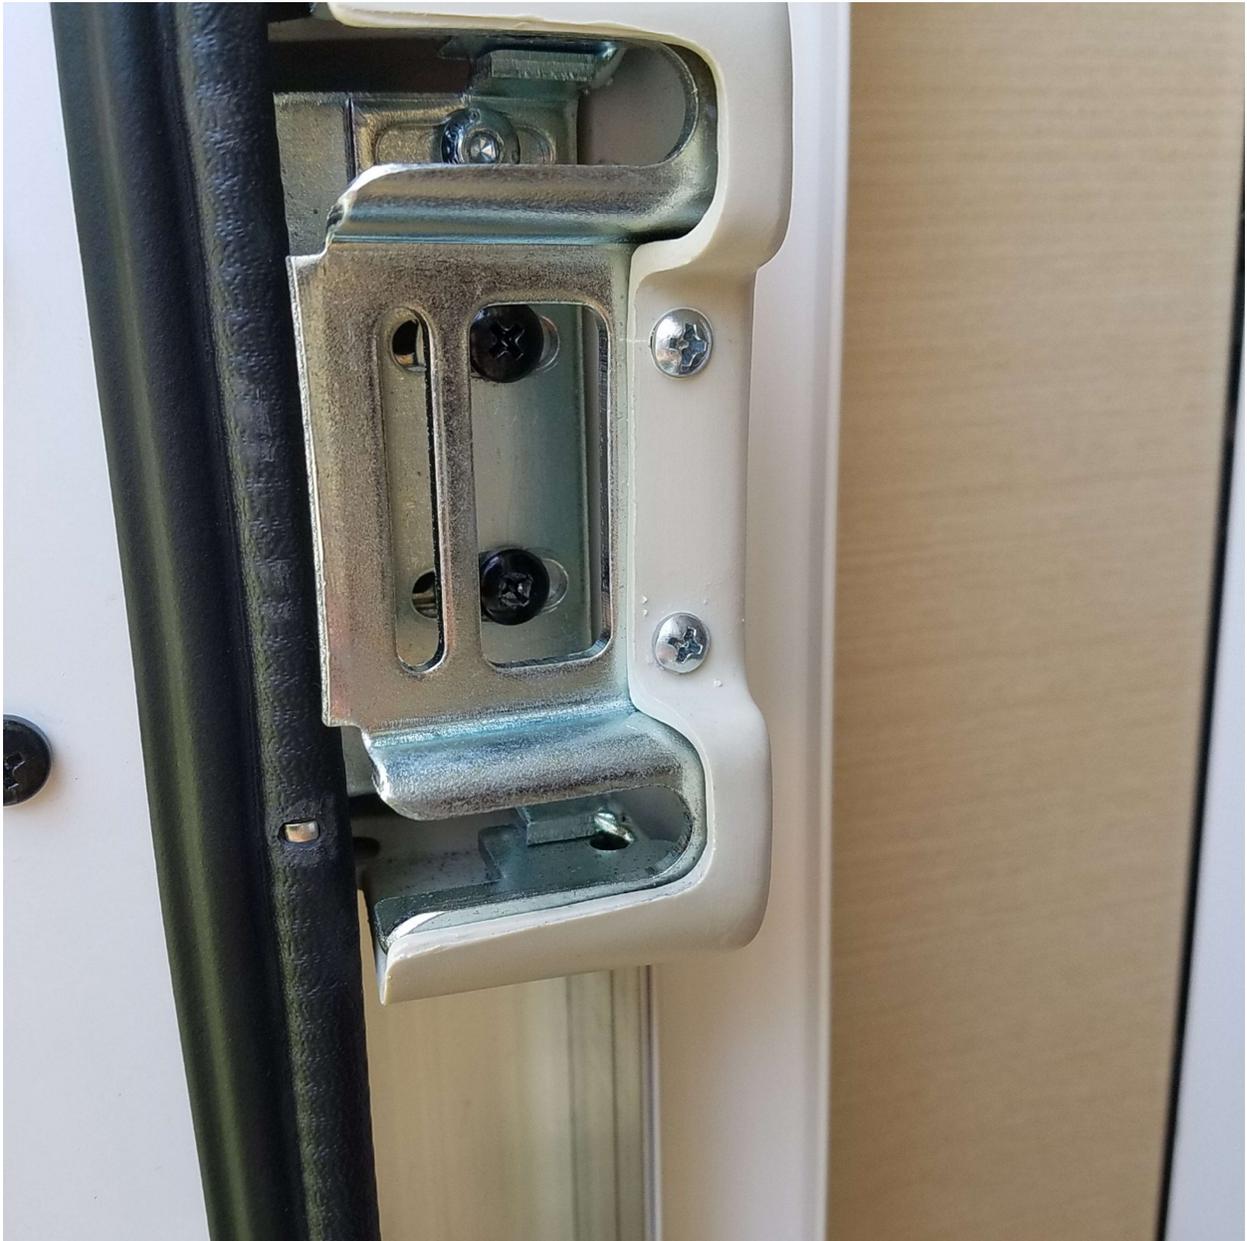
All back together. Needed longer M6 x 1.0 screws (black) as I had to put washers as shims between the plates to square up the lock plate. You can also see the damage to the door seal from the original loose lock assembly.

Now the door wouldn't close at all as the lock plate was solid with no play. I had to shim the lock plate with two washers to square it up. Then adjust the two anti-theft screws in the door lock to allow it to shut and lock. The screw heads in the door lock were set to just clear the door seal when closing the door. Now all was well. However, after a few door opens, the door was difficult to lock again, I saw the anti-theft screws on the door lock has turned. I put thread lock on them and so far seems good.

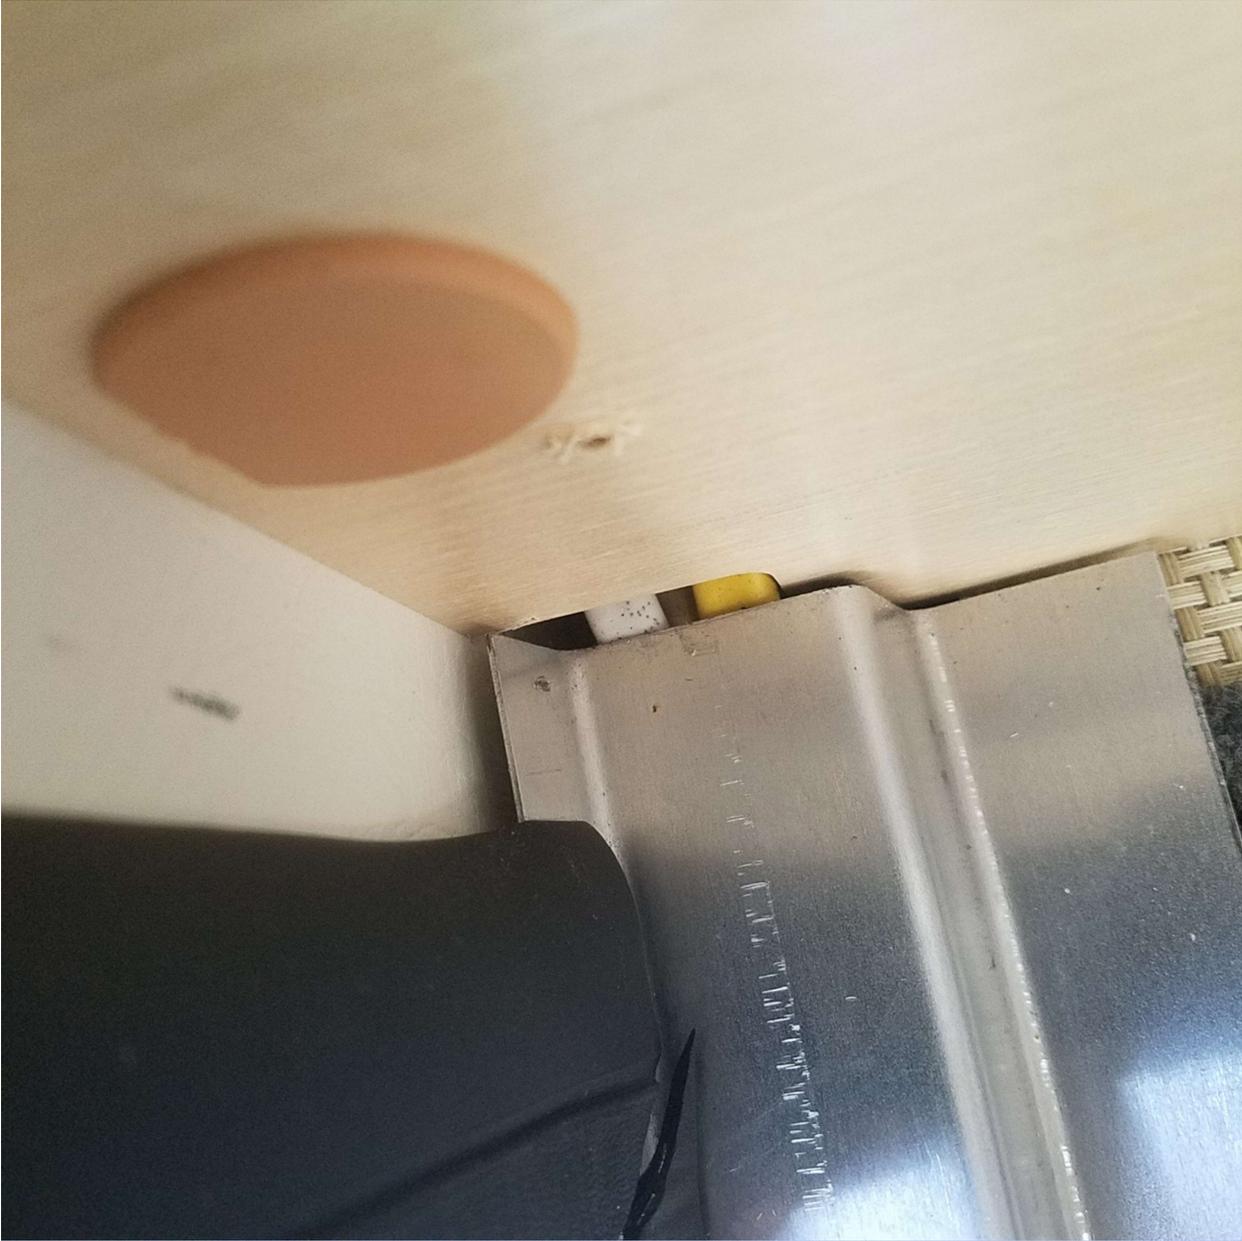
Shows the aluminum plate before removal. Note the cables are tight at the bend and pulling against the plate.

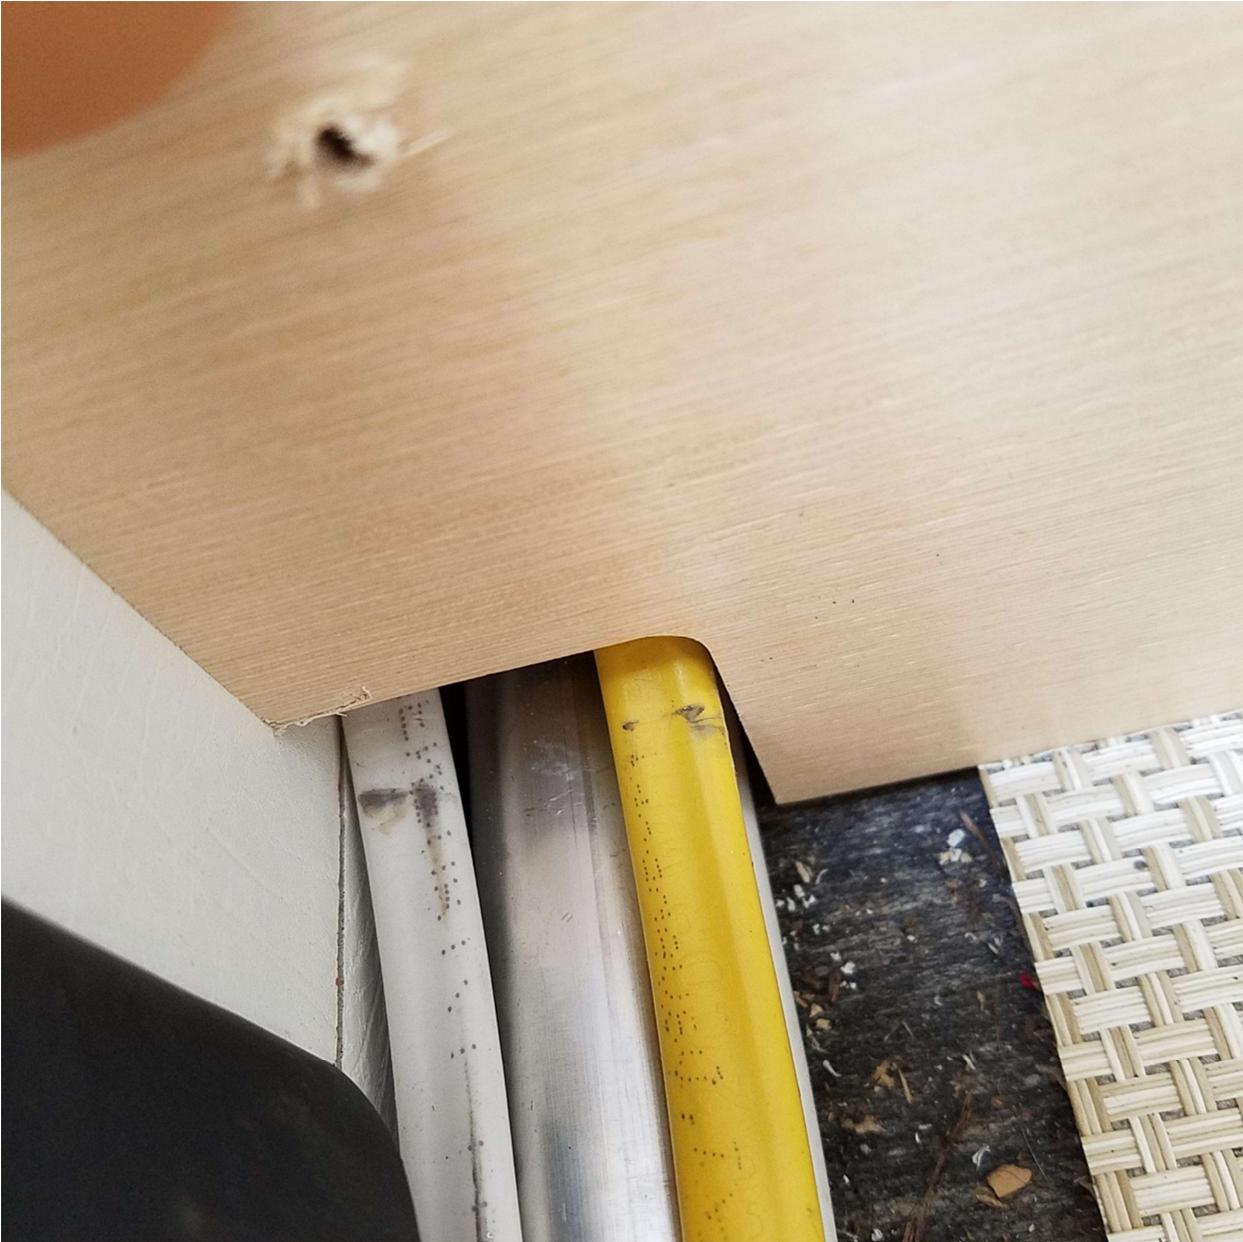
During the process of removing the inner door frame, I saw that the aluminum plate across the bottom of the door was cutting into some power cables. I removed the plate, which requires pulling off the lower door seal to lift it out. I saw that the cables had been partially cut through by the sharp edges of the aluminum plate. Fortunately, only the outer sheath was damaged. I purchased a piece of plastic surface wiring trunking 1 ¼ wide. I used the lid of this which I put over the cables under the aluminum plate. The trunking cover was cut to push into the holes both sides that the cable came through. The aluminum cover was then replaced and screwed down at the front. This looked much better. The bottom door seal was replaced on a bed of mastic and the corners joining to the main door seal were squirted with silicon.

This I think, could have caused a short if not remedied and the cable got cut through. This could lead to a fire at the doorway – a very dangerous situation.

Here you can see the cable damage with the aluminum plate removed. It was the same both sides. The grey marks are where the aluminum plate had started to rub through the cables.

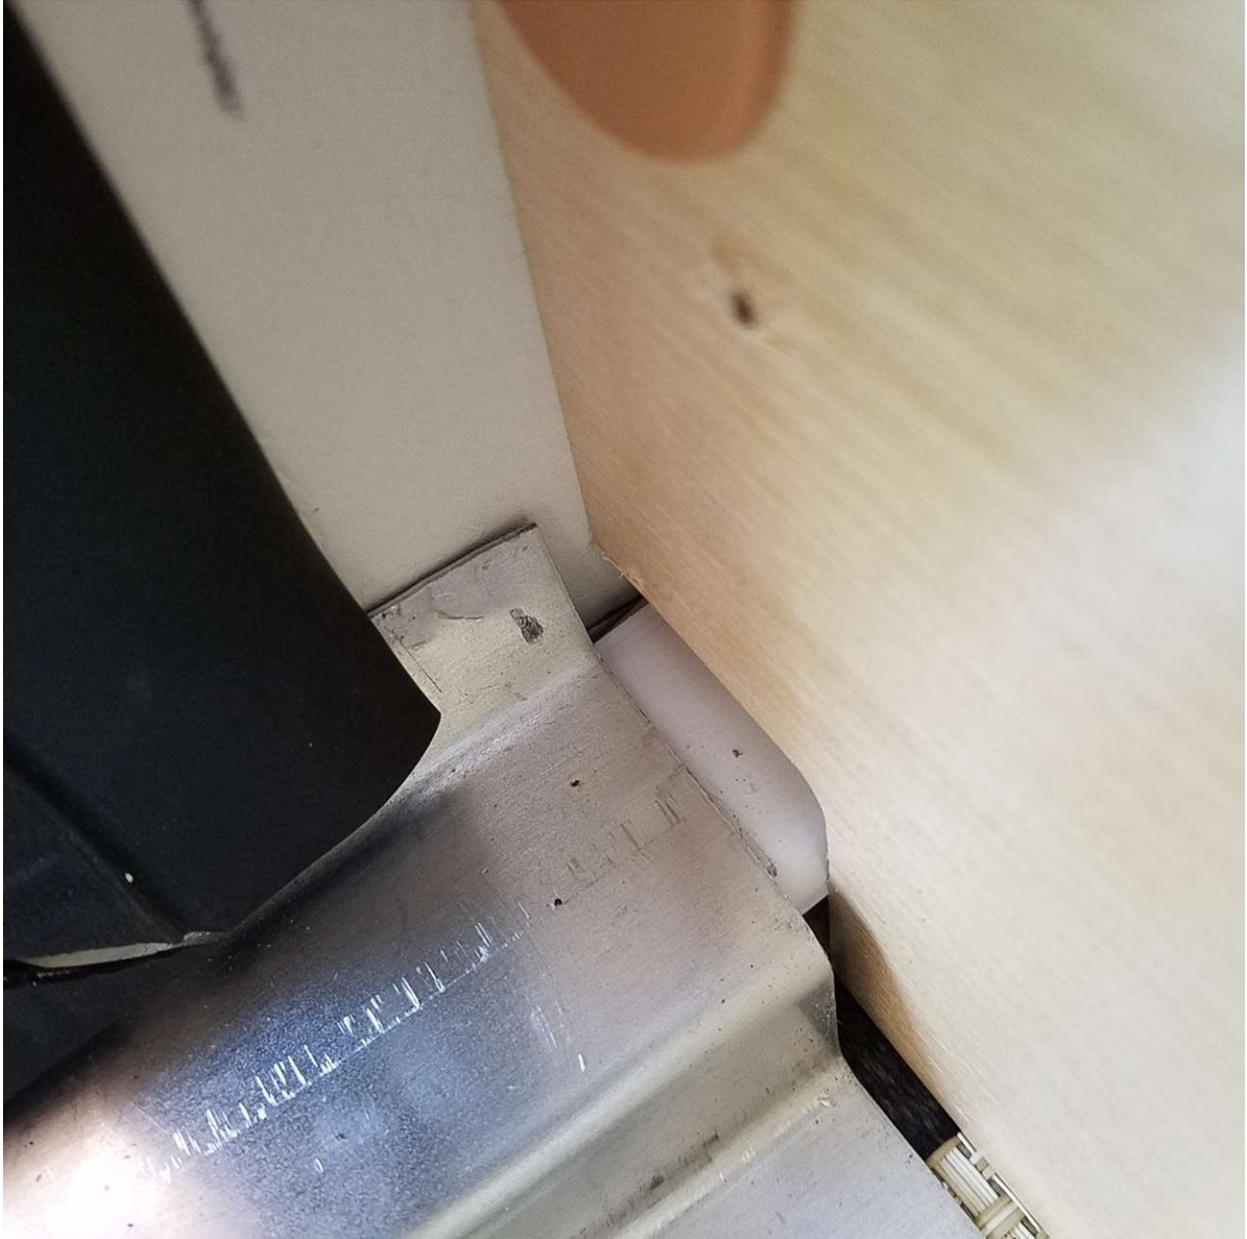
Here you can see the trunking cover pushed right inside the hole (both sides) thus preventing the aluminum plate from cutting into the cables. Shown here with the aluminum plate in position.

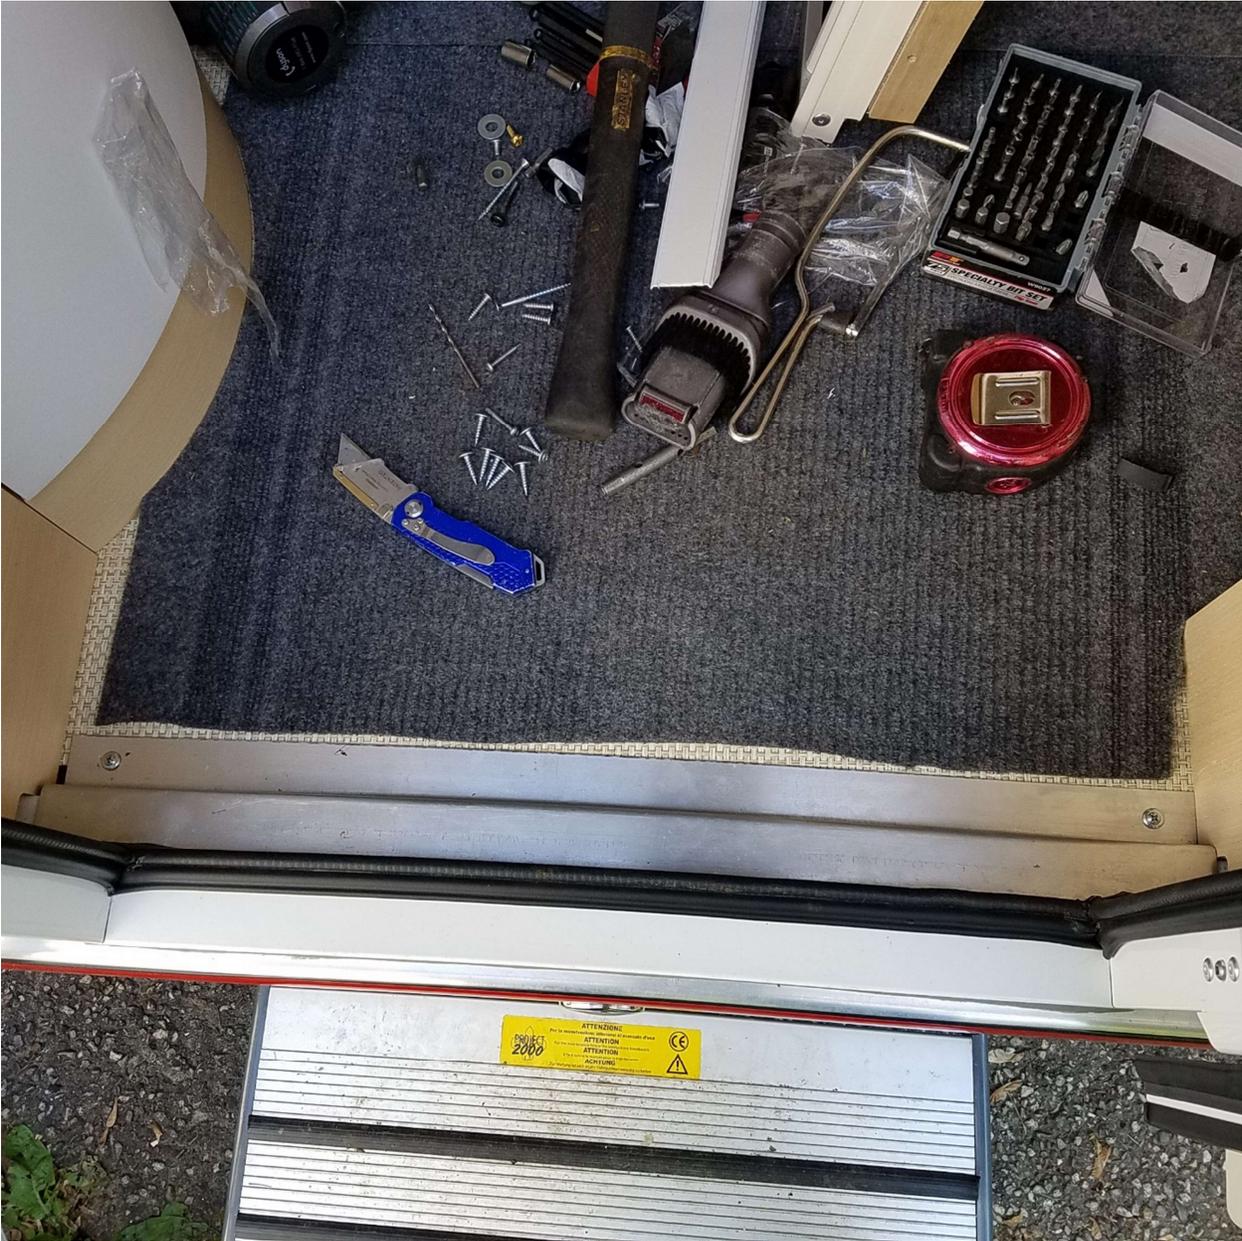
Aluminum plate shown fully in position and screwed down. I did put a screw in the middle too.

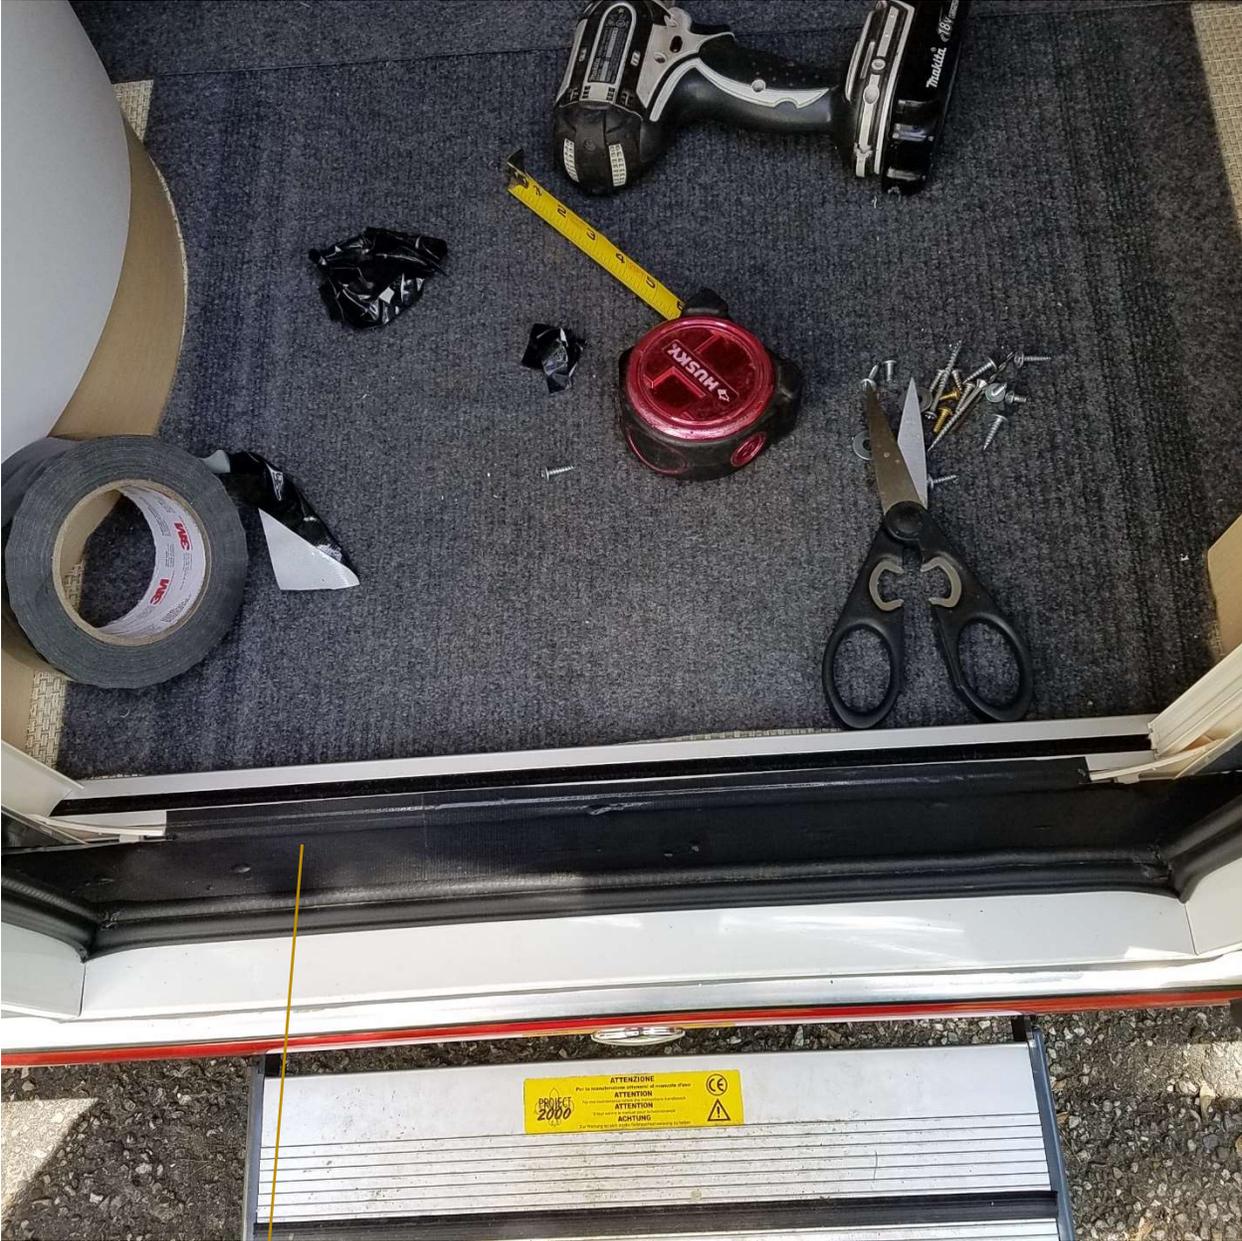
Gap is Here

With inner door frame in and secured. I put Black Duct tape over the gap left between the aluminum plate and the inner door from bottom. It would not go any closer.
