Service Bulletin

NCRV SB19-005

TAB 400 TAB 320 TAG CIRRUS 720 CIRRUS 820 CIRRUS 920 AVIA BAREFOOT

PROBLEM DESCRIPTION: Air Conditioner does not cool properly

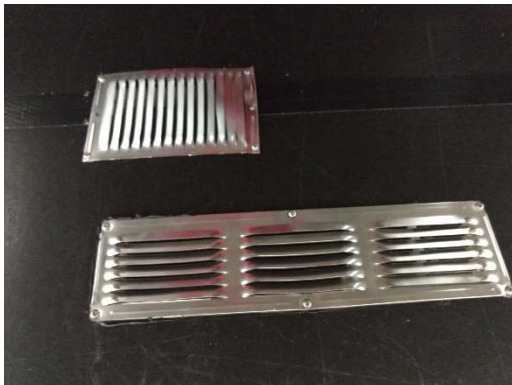
1. Remove both the Intake and Exhaust vents from the bottom of the trailer.

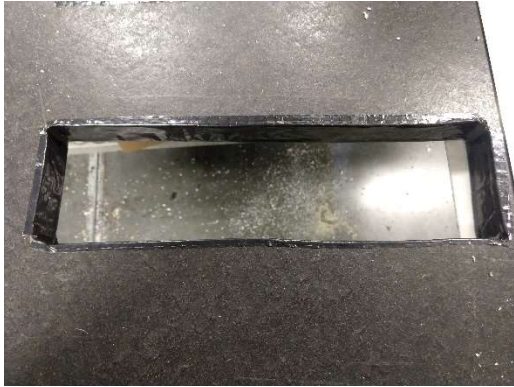
2. Tape/Seal edges of floor. Apply a bead of caulk around the perimeter of the vent.

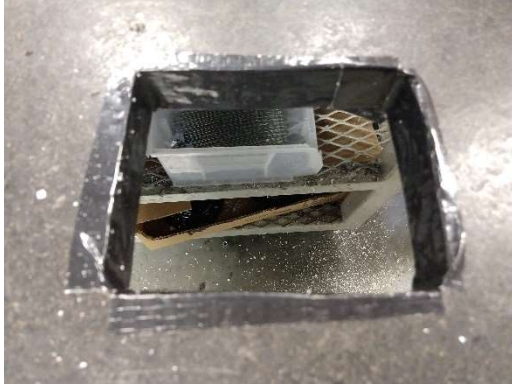
2. Tape/Seal edges of floor. Apply a bead of caulk around the perimeter of the vent.

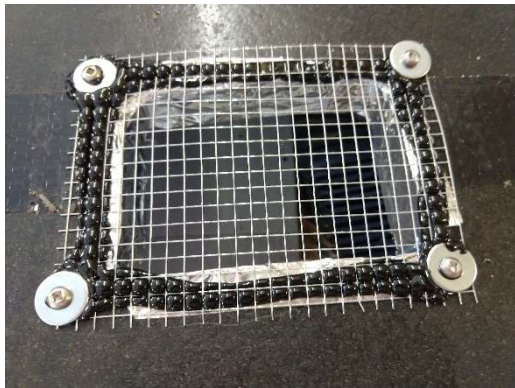
3. Screw hardware cloth with washers to bottom of floor.
