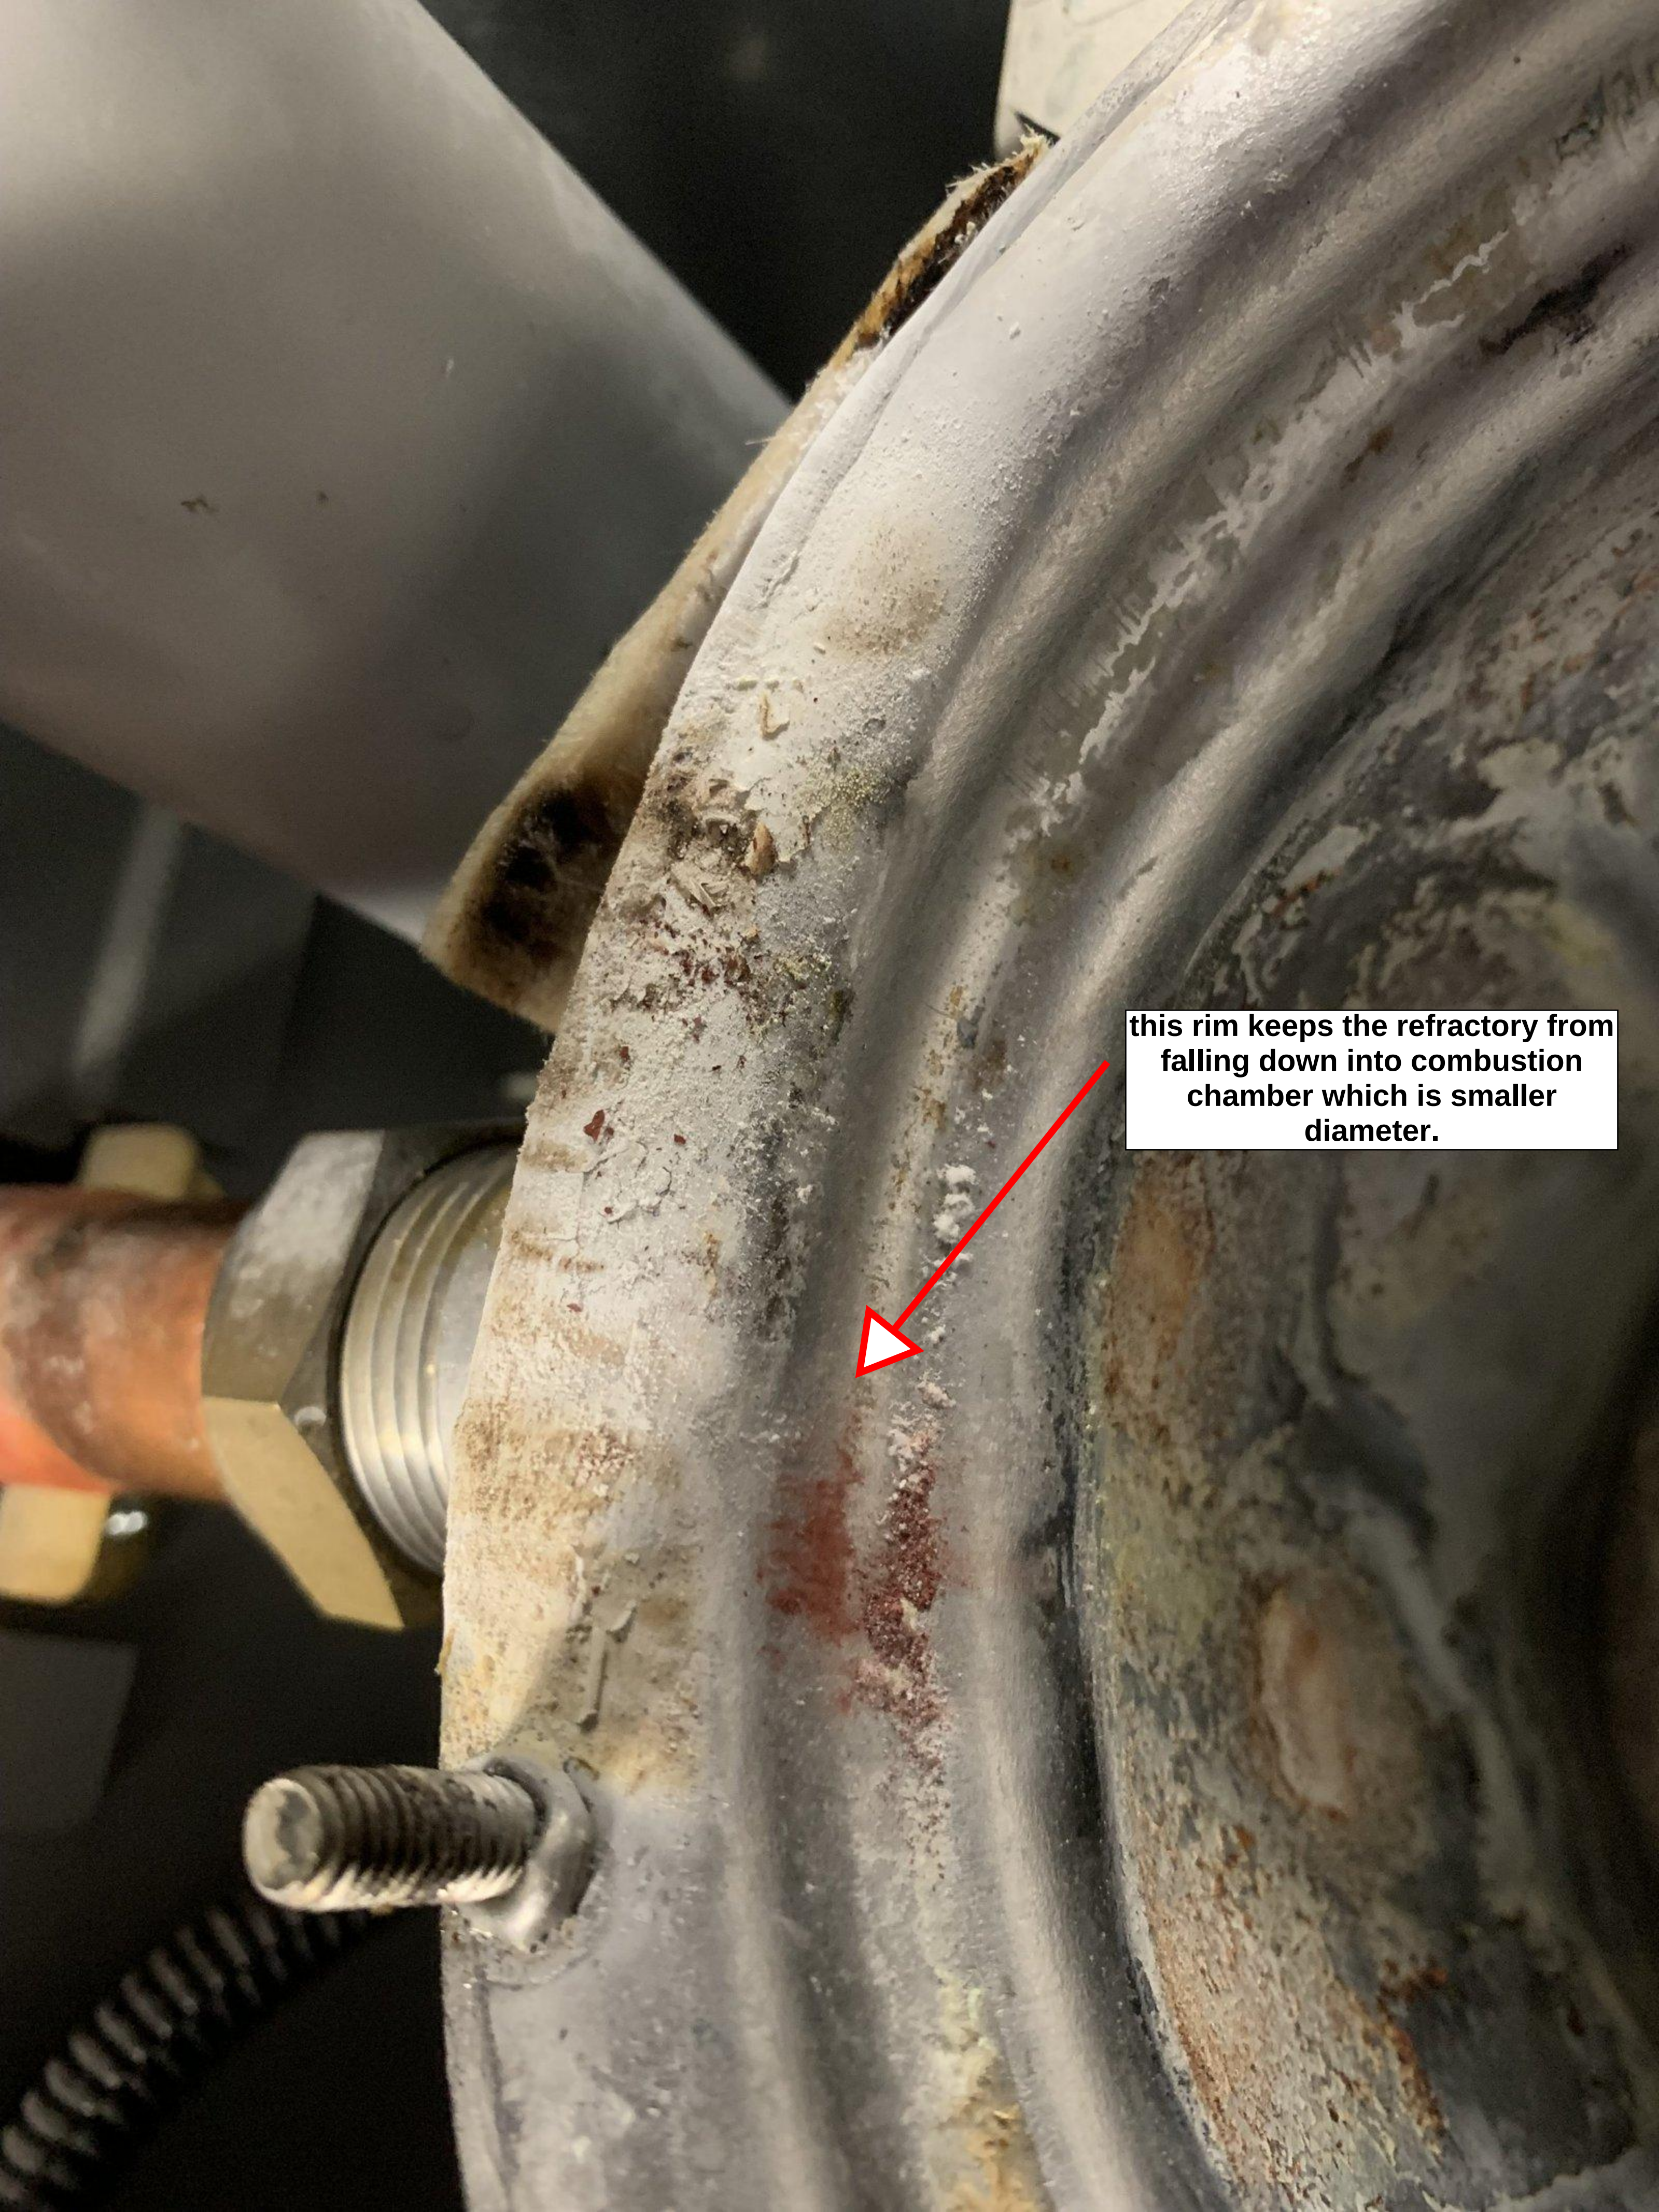
A close-up photograph of a metal rim, likely part of a combustion chamber. The rim is made of a dark, possibly cast iron or steel, material and shows signs of wear, including scratches and discoloration. A red arrow points from a text box to the rim. In the background, a white cylindrical object and a metal flange with a bolt are visible.

this rim keeps the refractory from  
falling down into combustion  
chamber which is smaller  
diameter.
